Napa County HISTORIC Courthouse

By Luke Wilson, S.E.,
Brett Shields, P.E.,
and Kevin Zucco, S.E.

Napa County HISTORIC Courthouse PART 2

Napa County HISTORIC Courthouse PART 3

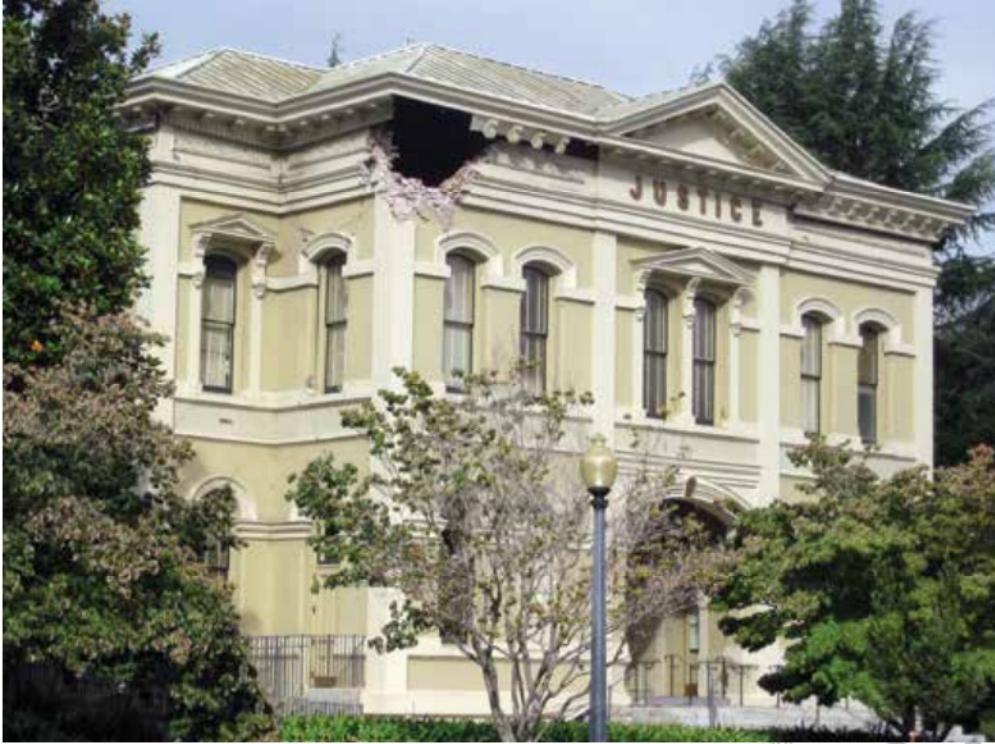
Figure 1. Entry showing damage; taken the morning of the Earthquake.

AT 3:20 AM, August 24, 2014, the Napa County Historic Courthouse was severely damaged in the magnitude 6.0 South Napa Earthquake, which induced nearby ground motion readings indicating spectral accelerations ranging from 0.4g to 1.7g for low period structures. Most obviously, the top of the south east corner at the front of the building (east face), along with its attached dental cornice, collapsed outward to the sidewalk below (*Figure 1*). The Initial review also revealed a partial collapse of the exterior brick wall on the north elevation. At one corner of the building, the top two to three feet of brick wall fell inward, collapsing the ceiling framing above the jury room (*Figure 2*). There was significant additional damage throughout the exterior and interior masonry walls and the building frequently appeared in news coverage as a prominent downtown public building affected by the Napa Earthquake. The Courthouse was subsequently red-tagged by the City of Napa (the building was deemed unsafe for occupancy or entry, except as authorized by the local building Authority Having Jurisdiction per Applied Technology Council, ATC 20-1), beginning the long process to assess the damage, repair, and reoccupy the historic structure.

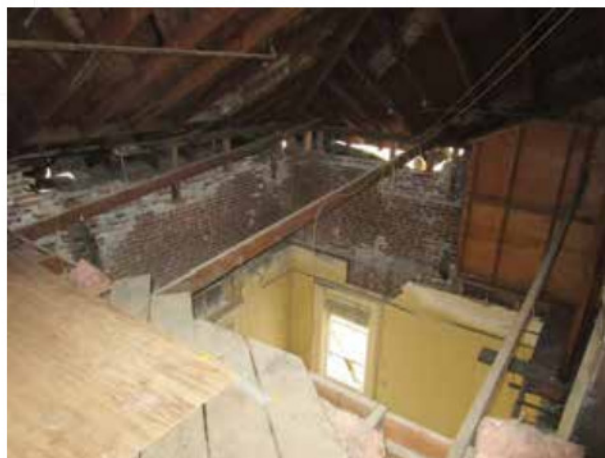
Figure 2. Courtroom view from the attic where brick partially collapsed the ceiling below.

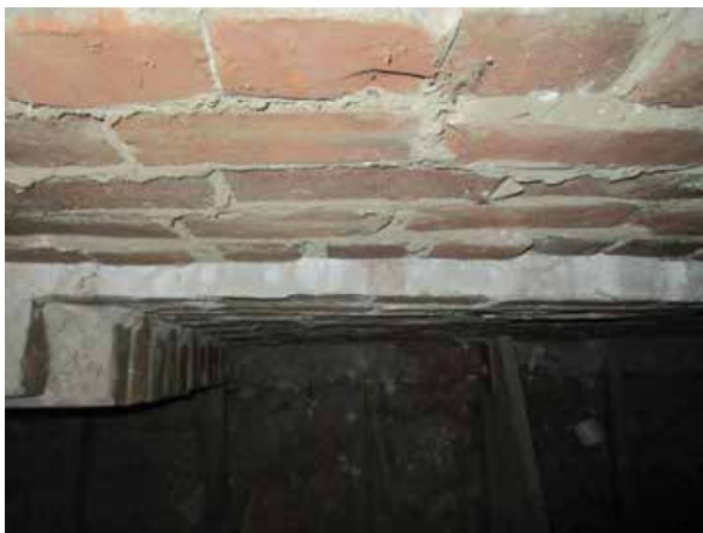
Figure 3. Horizontal offset of brick in the attic.

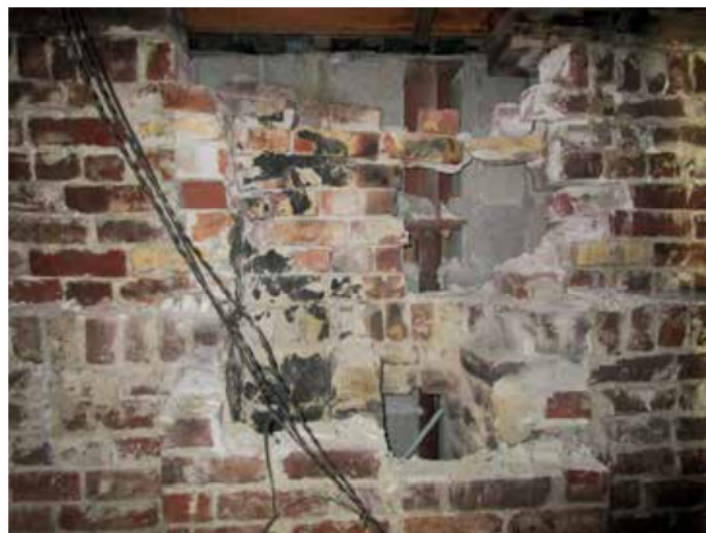
Figure 4. Partially collapse of URM wall due to adjacent Administrative Annex Framing.

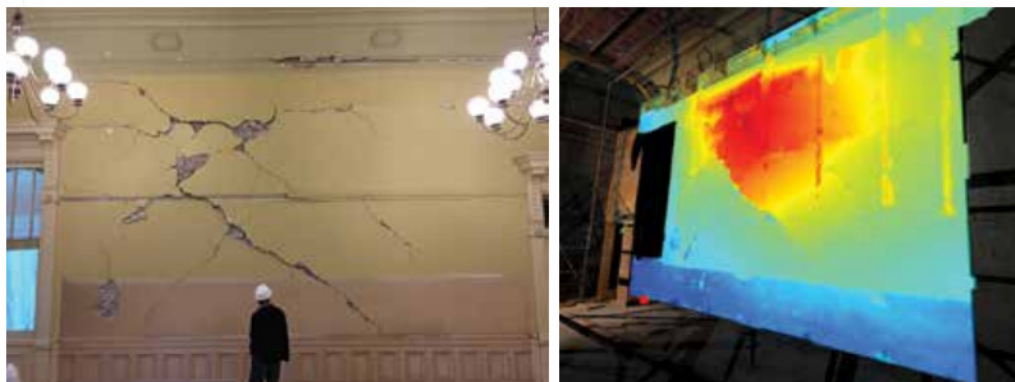
Figure 5. Site photo of damaged wall and heat map showing offset.

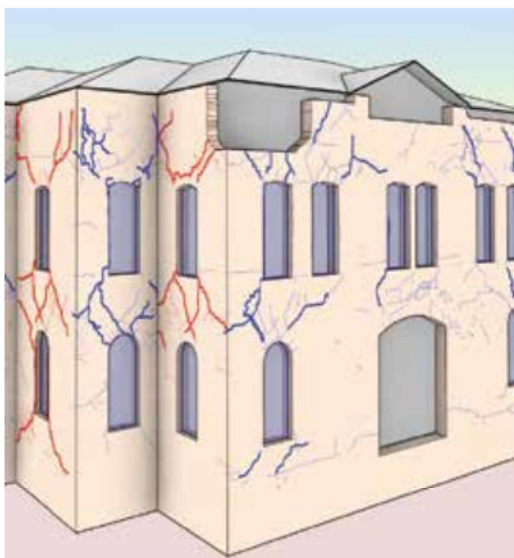
Figure 6. BIM Model showing entry damage (see Figure 1 for actual photo of area).

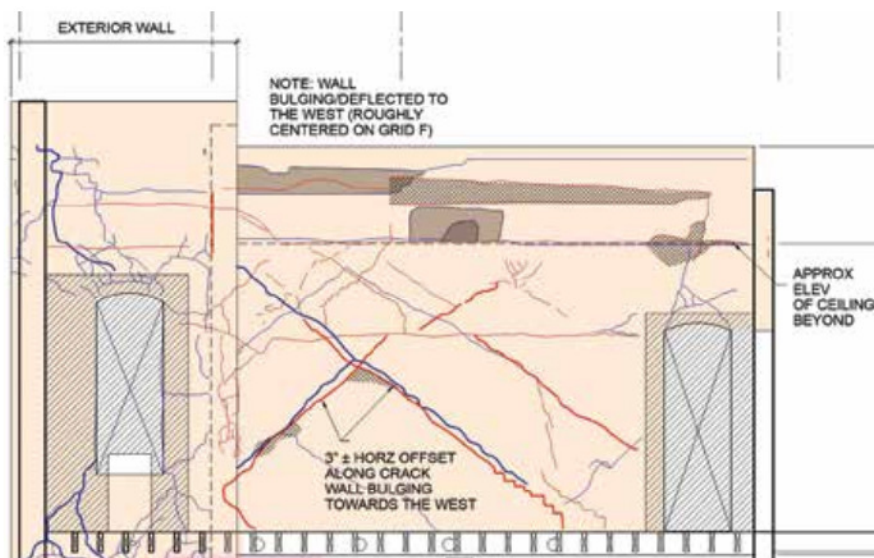
Figure 7. Example damage documentation drawings (see Figure 5 for an actual photo of the wall).

Using the damage documentation 3-D BIM model (Figure 6), two-story full-length wall elevations and 3-D views clearly illustrated crack patterns on both sides of walls (Figures 7 and 8). Using this whole-building approach to documenting the damage, significant two-story diagonal crack patterns were revealed that extended through wall faces, providing valuable insight into the global building behavior and resulting damage extent from the earthquake.

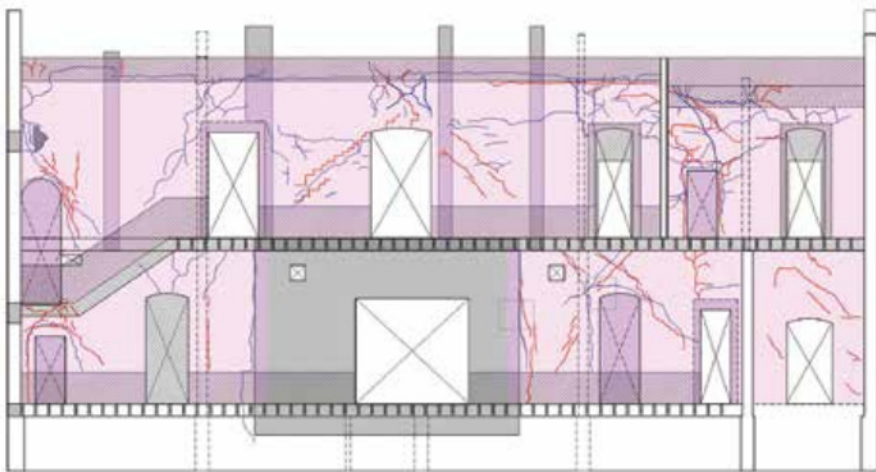
Figure 8. Two-story section through the main hallway showing damage documentation.

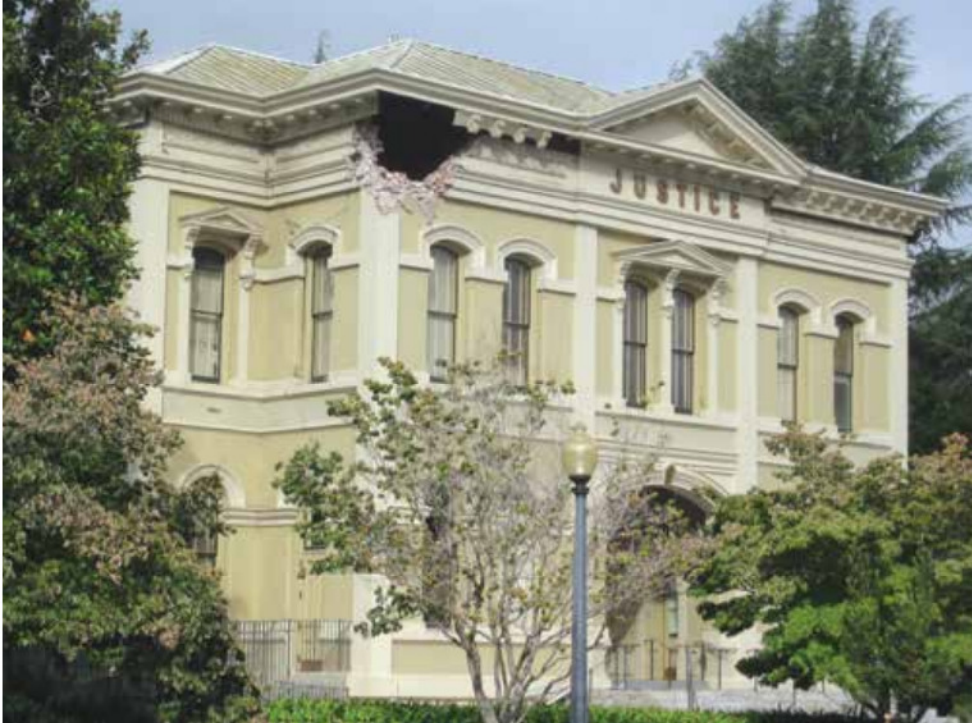
Figure 1. Entry showing damage taken the morning of the earthquake.

On August 24, 2014, the South Napa Earthquake left the Napa County Historic Courthouse heavily damaged with partially collapsed walls, ceilings, and extensive wall cracking (Figure 1). The City of Napa red-tagged the courthouse as un-occupiable, which began the extensive damage documentation effort outlined in the December 2019 edition of *STRUCTURE*. After documenting and assessing damage, the design team refocused efforts towards a solution to repair and preserve as much of the historic building as practical while providing improved detailing.

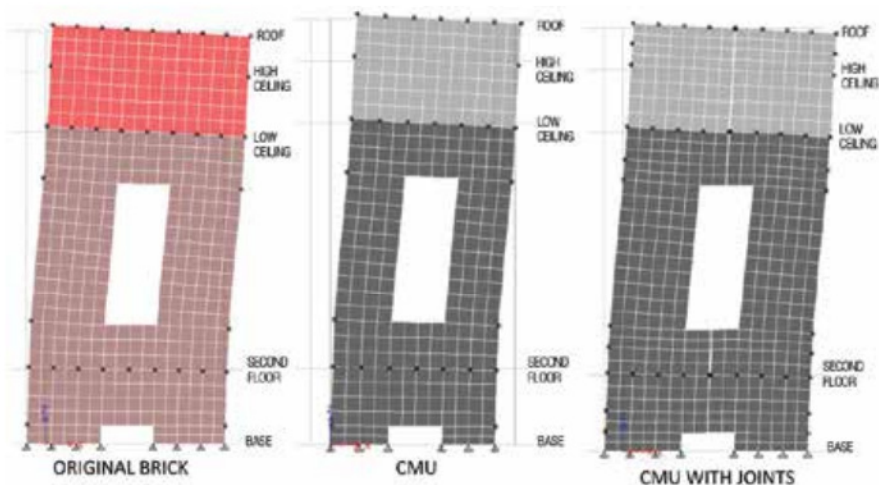
Figure 3. Analysis model showing original brick, CMU, and CMU with control joints.

These adjustments did not provide the desired reduction in stiffness; therefore, strategically located control joints were added to further reduce the stiffness of the areas rebuilt with CMU (Figure 3). The

final design included a stacked bond, in lieu of a traditional running bond and control joints located above and below windows, at reentrant corners, and regular vertical spacings in long rebuilt walls. The final layup more closely matched the stiffness of the original brick walls such that new walls work in unison with existing walls, and lateral loads are not concentrated in any one area. Additionally, many of the exterior reentrant corners, whose stiffness concentrated seismic load and deformations, were reconstructed out of CMU with control joints in the corners to decouple perpendicular walls.

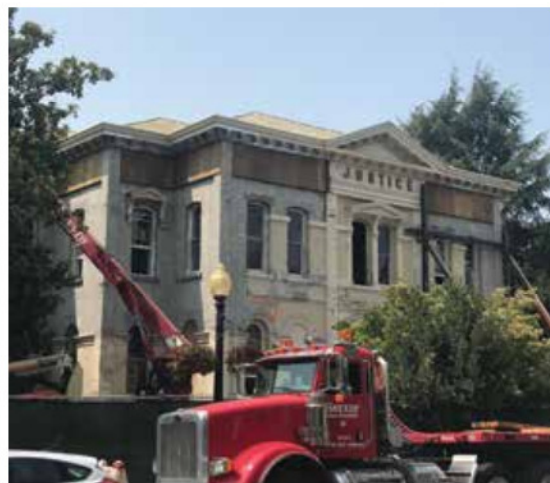
Figure 4. CMU reconstruction of damaged 2nd-floor walls.

rebuilding a new “straight” wall between two existing points (*Figure 4, page 23*) while still supporting the floor and ceiling. This condition was resolved through shimming of ledgers at small gaps and providing bearing angles at larger offsets.

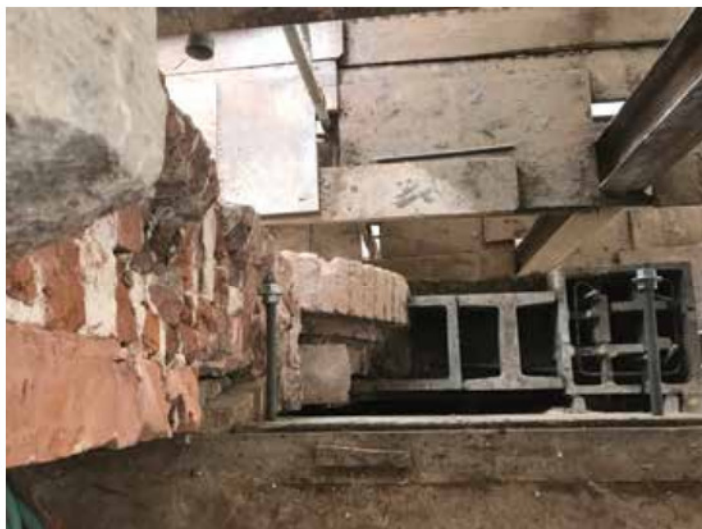
Figure 5. Detail of CMU interface with historic brick arch.

While CMU has some adjustability to accommodate small existing dimensional offsets, the number of intricate interface conditions to existing construction was a challenge. CMU had to interface with historic brick arches (*Figure 5, page 23*), existing floors and ceilings, adjacent precast concrete lintels (*Figure 6, page 23*), uneven base levels, wall anchorage, and existing penetrations while adjusting to match existing walls. The result was a number of details, both planned and unforeseen, requiring a level of mason care and ability beyond that of typical construction.

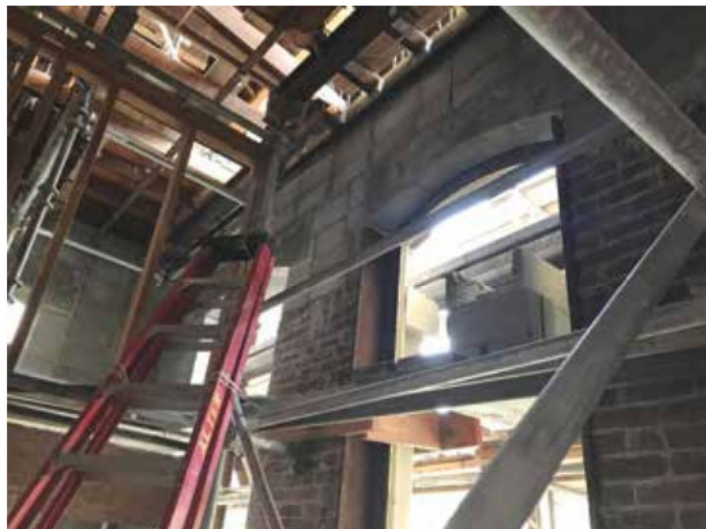
Figure 6. CMU and precast lintel construction above the original brick wall.

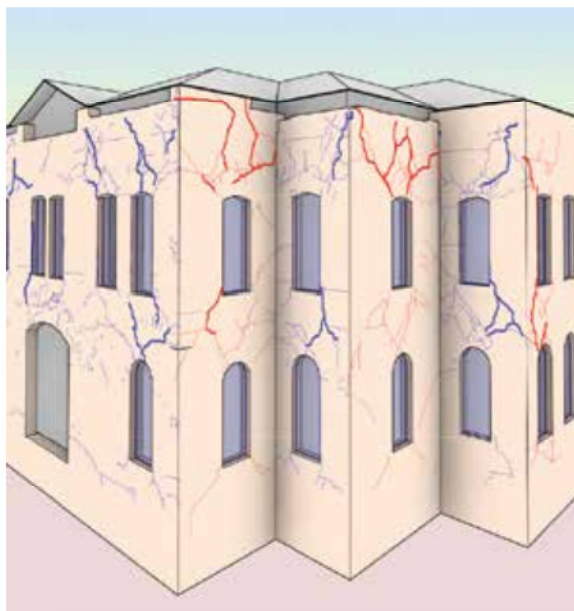
Figure 7. Example of damage documentation drawings.

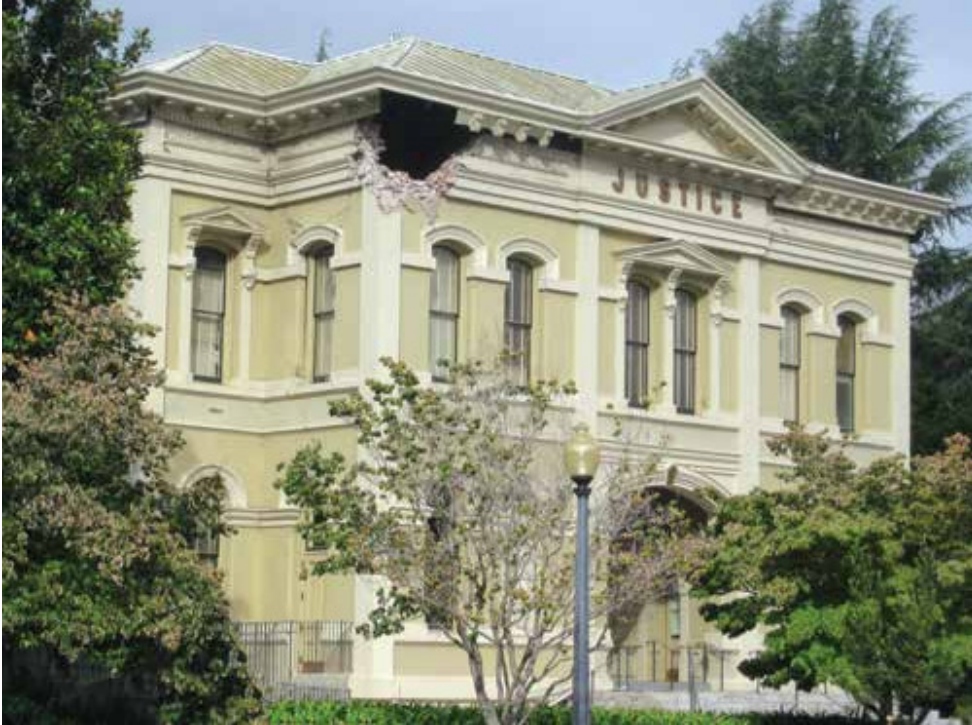
Figure 1. Entry showing damage taken the morning of the earthquake.

On August 24, 2014, the South Napa Earthquake left the Napa County Historic Courthouse heavily damaged with partially collapsed walls, ceilings, and extensive wall cracking (Figure 1). The City of Napa red-tagged the courthouse as unoccupiable, which began the extensive damage documentation and repair effort. The overarching goal throughout this process was to provide a solution to repair and preserve as much of the historic building as practical while providing improved detailing.

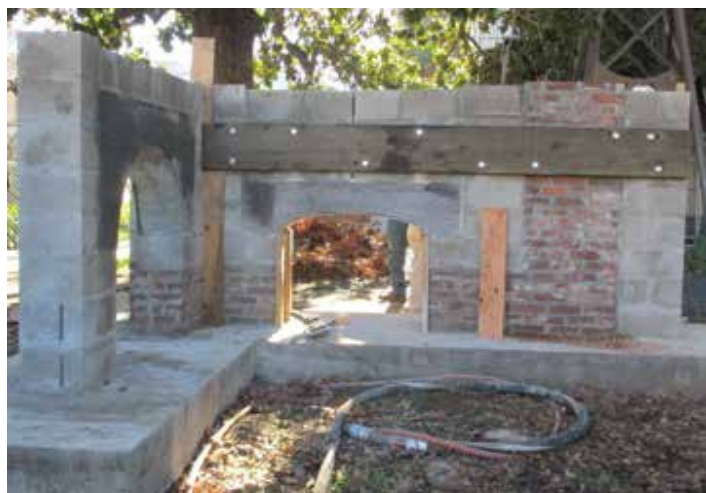
Figure 3. Mockup prior to installation of FRCM.

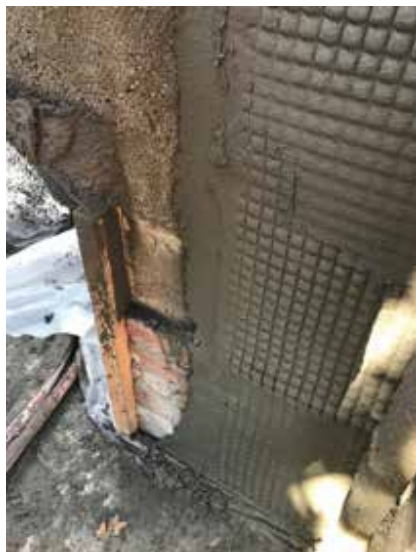
Figure 4. FRCM fabric being installed into matrix.

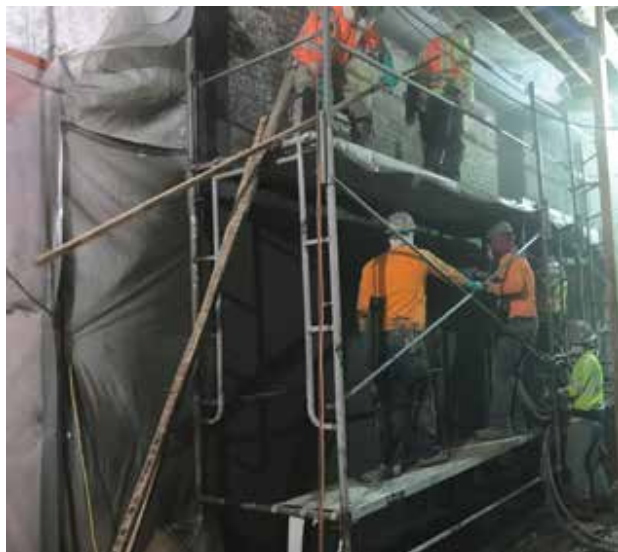
Figure 5. FRCM installation.

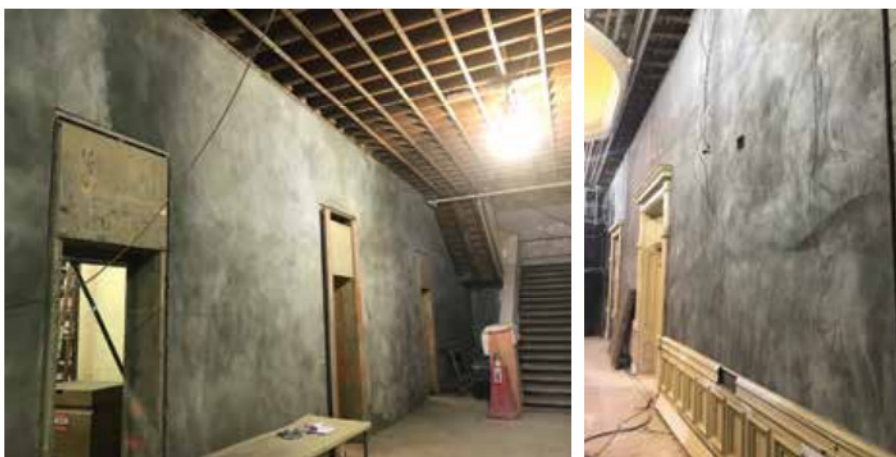
Figure 6. Finished FRCM installation on first floor (left), second floor (right).
