REPAIR AND RETROFIT IN THE AFTERMATH OF THE 2014 NAPA EARTHQUAKE

By Chris Jonas, S.E., and Steve Heyne, S.E.

HISTORIC GOODMAN LIBRARY

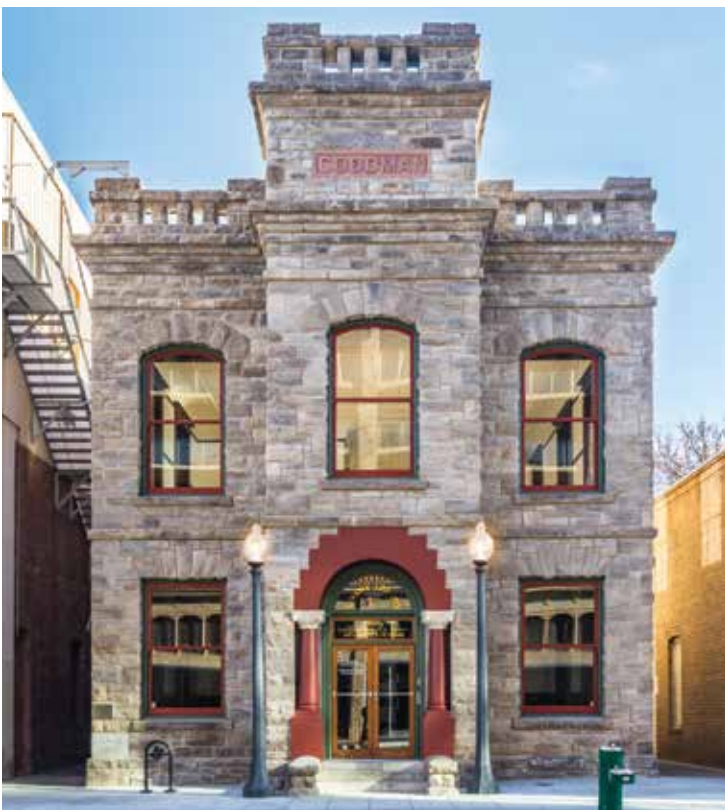
Restoration of the Goodman Library completed December 2017. Courtesy of Justin Lopez Photography.

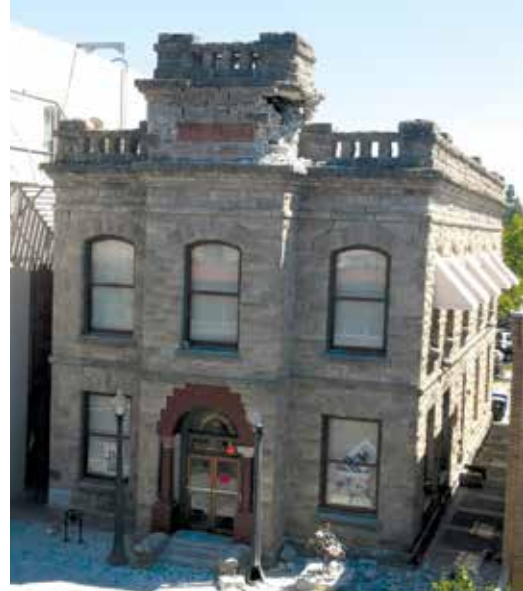
The focus of the post-earthquake damage investigation was the tower, where the partial collapse allowed large stones to fall 30 feet to the sidewalk below. Exploration within the tower cavity revealed minimal existing lightweight steel frames for support. These frames, likely part of the 1970s retrofit work, lacked adequate stiffness to prevent substantial displacements of the stone. Additionally, the rock anchors from the steel frame to the stone masonry were an expansion style anchor embedded only into the inner wythe, leaving the outer wythe unsupported. Not only was a new, stronger frame needed within the tower, but external bracing from the backside of the tower to the roof framing was also recommended to reduce displacement of the tower and alleviate the deficiency. Before embarking on the design, however, SHPO required a visual assessment of the impact of the proposed external steel braces from street-view. Approval was granted after a simulation using BIM

Figure 1. Library after the earthquake.

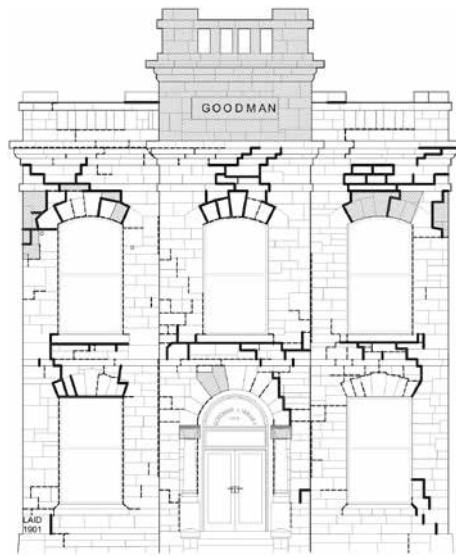
The architectural and structural engineering teams performed an extensive survey of the damage. It was evident upon closer inspection that there was significantly more damage to the stone walls than initially suspected. Each stone and every crack was recorded by hand on building elevations for later conversion to electronic drawings (Figure 3, page 32). Stones that were damaged or dislodged were noted in detail, as this

Figure 3. Extensive documentation of damage.

Segments of the stone walls that were displaced and significantly cracked were to be documented, then disassembled and rebuilt to historic standards. Other less damaged areas were repointed and grout-injected with historically accurate lime-based grout to regain the structural integrity of the wall. Contrary to popular belief, replacement mortar and grout should contain low amounts of cement compared to lime so that it is

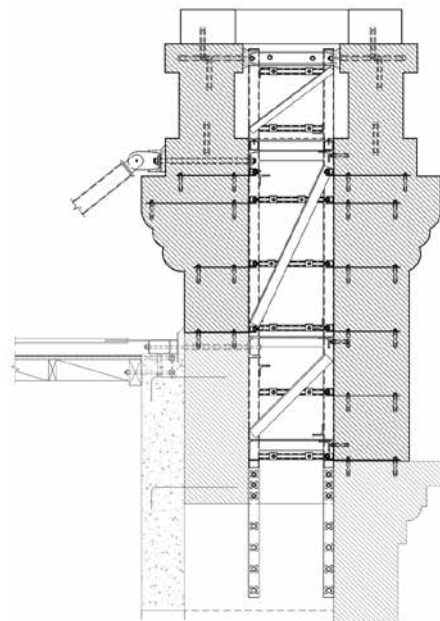
Figure 4. New steel space frame designed to fit within tower core.

The new steel space frame, composed of angles and channels, was designed to fit within the core of the vulnerable tower, acting as a backbone (Figure 4). Provisions from ASCE7-10 for a braced non-structural cantilever element were used as the basis of design, the same as would be used for a braced parapet or chimney. It is worth mentioning that the CHBC requires parapets and similar exterior decorations to comply with regular code requirements for anchorage and strength, recognizing the public safety hazard these elements present. Though inserting a stiff space frame could result in higher accelerations at the tower, it was the preferred solution to limit local displacement which could lead to wide, cracked mortar joints and then dislodged falling stones. Detailing of the frame was explicitly designed for flexibility of installation by skilled masons from Rainbow Waterproofing & Restoration Inc. As individual layers of stones were reinstalled in their original positions around the tower, heavy steel straps were laid within the horizontal mortar beds, interconnecting the interior and exterior wythes, and attached to the steel frame with self-drilling screws (or field welds) at specified locations. The closely-spaced straps were attached to the stones with two vertical adhesive anchors and hidden within the bed joints of the tower walls. This versatile connection detailing allowed for flexibility during the installation by the masons as they reconstructed the tower over several months. During reinstallation, some stones were deemed too damaged for reuse. Fortunately, a nearby historic URM building recently completed a remodel and had leftover matching stones available, allowing the tower to be rebuilt entirely from local, historically accurate materials.
