The Historic Trefethen Winery

Repair and Retrofit in the Aftermath of the Napa Earthquake

By Marianne Wilson, S.E., Kevin Zucco, S.E., and Brett Shields, P.E.

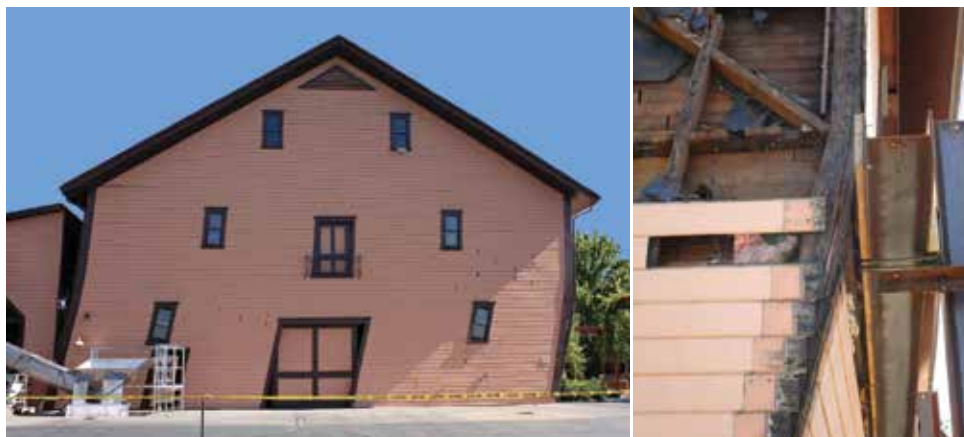
In the immediate aftermath of the 6.0 magnitude Napa earthquake on August 24, 2014, the historic structure rested in a precarious tilt with the second and third story shifted approximately four feet to the west (Figure 2). Nearby ground motion readings indicate spectral accelerations ranged from 0.4g to 1.7g for low-period, one- to two-story wood framed structures. The largest deflection occurred at the North end of the second-floor level where water-filled tanks and barrels were stored at the time. The filled water tanks constituted a large concentrated mass at the northern end of the second floor, increasing the seismic forces acting in this area where the larger localized horizontal deflections occurred.

With the potential for total building collapse an aftershock away, steel shoring and cribbing were immediately erected to prevent further offset and to support displaced gravity members. The timber-framed gravity system was constructed without positive connection between posts and beams, or posts and foundations, allowing posts at the

Figure 2. Post-earthquake deflection and localized damage at second-floor level.

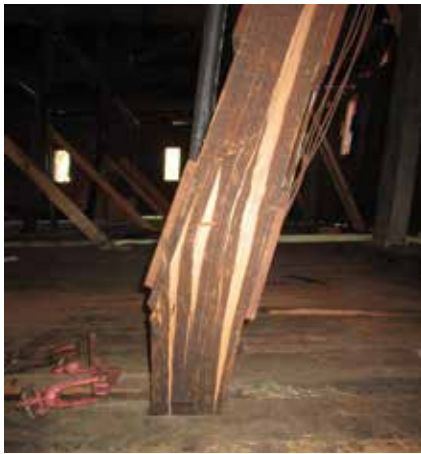
first level to rotate and “walk” without resistance as the building cycled through deflections. While this lack of connection restraint released the lower level posts and beams from sustaining significant damage at connections, the magnitude of the deflection caused several first-floor posts to disengage completely from beneath the beams. Second level posts adjacent to the diaphragm step at the center bay were constrained within a several-foot-tall pony wall between the diaphragm levels. This resulted in a significant amount of flexural damage to the posts directly above the main second-floor level (Figure 3). Multiple posts at the upper levels sustained damage at let-in

Figure 3. Damaged post at a step in the second-floor diaphragm.

beam connections where large splits developed at interior corners of cuts. Significant structural documentation was performed through multiple site visits to understand the existing framing systems and connections fully. A 3D point cloud survey was also taken of the structure in its deformed state to aid in shoring design and erection. When overlain onto a non-deflected Building Information Model, the 3D point cloud helped to illustrate existing atypical framing and provide further insight into the extent of the deformations developed within the structure (Figure 4), as well as shape the retrofit strategy.

New bolted steel side plates, configured for minimal visual impact, provide positive connections at gravity framing between existing beams, posts, and foundations. Bolted steel fitch plates provide additional flexural strength to floor beams, as required, resulting from occupancy changes at the upper levels. Damaged or split framing members are repaired in-situ with color-matched injected wood epoxy and bolted steel side plates wherever possible. Nearly all original framing members were preserved, with very few completely replaced.

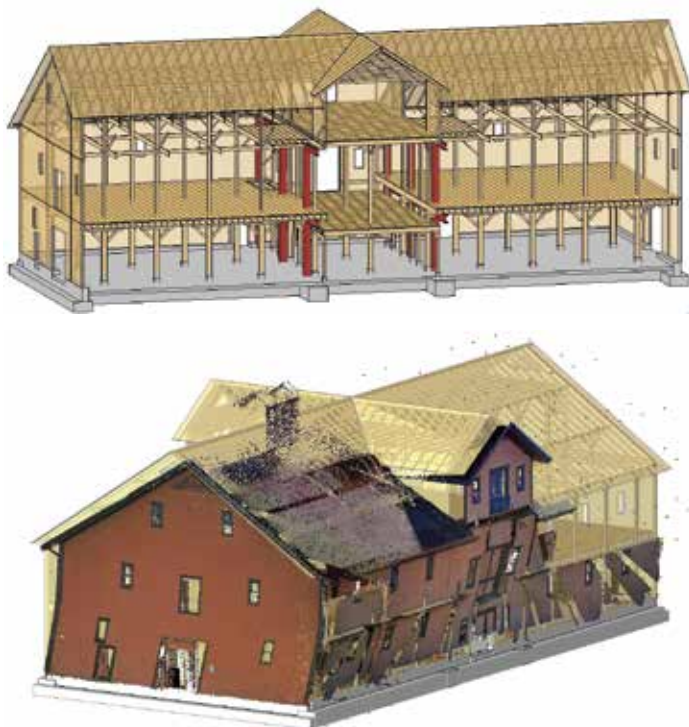
Figure 4. REVIT model including deflected shape 3D point cloud.

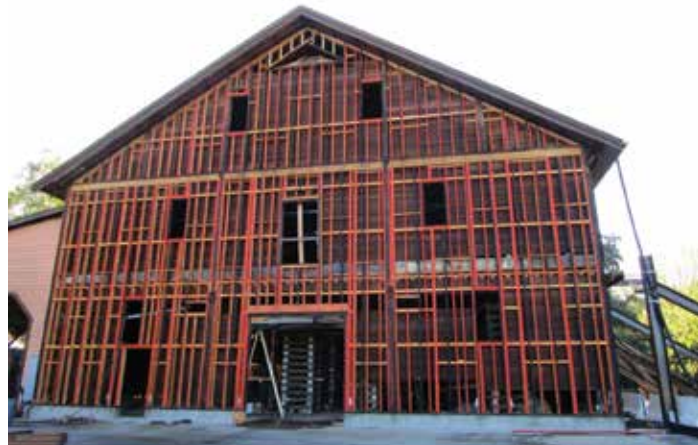
Figure 5. Retrofitted gable end wall framing.

While the existing straight sheathing at the exterior of the structure would have been adequate to resist historical building code lateral loading for most locations, plywood shear walls added to the full exterior increase the structure's seismic capacity and resiliency. To preserve the more unique and fragile interior redwood siding, temporary removal of the exterior straight sheathing, which suffered significant damage in the earthquake, allowed for installation of new plywood. Additional wall framing members were added to complete the load path for out-of-plane forces and provide minimum stud spacing for the new shear walls (Figure 5). Full height Laminated Strand Lumber (LSL) studs accommodate the stud length required at gable end walls. As an added benefit to exposing the wall framing, rigid insulation was installed improving the energy performance of the structure. The straight sheathing was painstakingly labeled before removal for refurbishment to ensure accurate reinstallation, to maintain the correct historic aesthetic at the exterior, and trim elements within the window openings were coordinated with the historical architect to accommodate the additional 1/2-inch wall thickness.

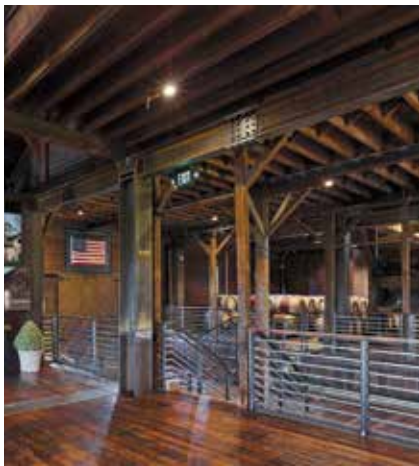
Figure 6. Finished interior at steel moment frame. Courtesy of Adrian Gregorutti and Trefethen Family Vineyards.

including fire risk from welding, the frames are configured into smaller “portal frame” pieces. The moment connections were prefabricated with beam and column stubs, locating bolted splice connections in each beam and welded splices at columns away from the adjacent historical combustible material. This prefabricated portal frame assembly allows smaller pieces to be installed within the confined spaces of the structure with minimal modifications to existing framing. An additional challenge in the design of the moment frame was the offset from the primary bearing line to maintain existing post and beam elements. Custom steel shear transfer plates with vertically slotted holes accommodate the horizontal offset from frame to diaphragm elements, while simultaneously allowing vertical tolerances in existing framing elevation. These were spaced to accommodate the reinstallation of historical knee braces at posts.

floor diaphragms were inadequate for seismic design forces as configured. The addition of new interior lateral force resisting elements reduced the existing diaphragm spans, allowing the diaphragm to remain without strengthening. Ordinary steel moment frames were selected to maintain the open post and beam feel of the space and to minimize the prescriptive detailing requirements. The flexible diaphragms in the east/west direction allow the gable end, wood shear walls to be designed for a standard Response Modification Coefficient (R) of 6.5, and interior ordinary steel moment frames be designed for an R-value of 3.5. Third-floor wood framed shear walls over moment frames were designed for the moment frame R-value. Steel frame columns were located immediately adjacent to existing timber posts to reduce their impact on the character of the space (Figure 6). Because of installation logistics,

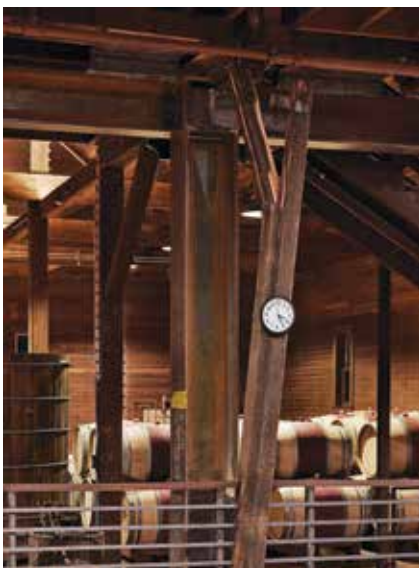
Figure 7. Remembrance post. Courtesy of Adrian Gregorutti and Trefethen Family Vineyards.

multiple generations have grown up in the winery and, specifically within this building, as children playing amongst the barrels as their parents worked. The family considered the earthquake repair of the structure not as something to be hidden, but as another significant chapter in the life of the historic building. With the structural repairs and improvements, not only did the building survive but was made stronger, continuing its legacy as a living piece of winemaking history in Napa Valley. As a final tribute to the earthquake that rocked the structure, additional steel gravity framing was provided so that a single Remembrance Post could be left in its destructed state to illustrate the magnitude of the event the structure withstood at 3:24 am, on August 24, 2014 (Figure 7).
