Building Outside the Box for a New School

A charter high school in Northern California planned to make a large commercial building its new permanent home, but first the structure needed to be given a seismic upgrade without disrupting the other tenants.

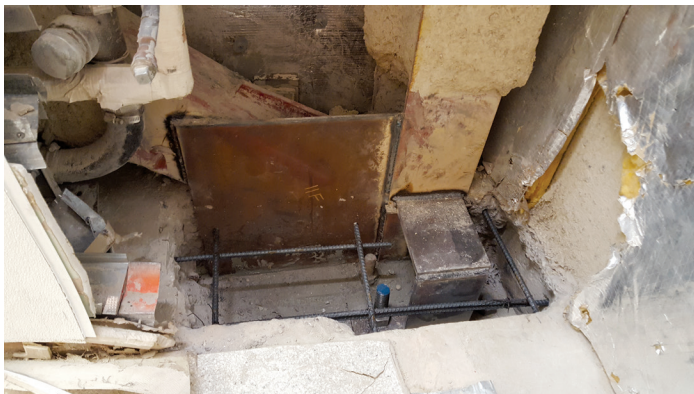
Figure 1. Base of existing braced frame column retrofitted with new gusset plates and anchor bolts.

The lateral force-resisting system is ordinary steel concentric braced frames. The ground floor braced frame connections are often partially embedded in the concrete floor slab (Fig. 1). The foundations consist of grade beams spanning to concrete piers with an interior slab-on-grade.

Existing shear transfer to the foundation was adequate, however tension capacity of the anchor bolts was not. New anchors were added to existing base plates either by drilling new holes or adding gusseted plate extensions (Fig. 1). Fortunately, the existing foundations worked for the braced frames, precluding disruptive interior slab removal and foundation excavation.

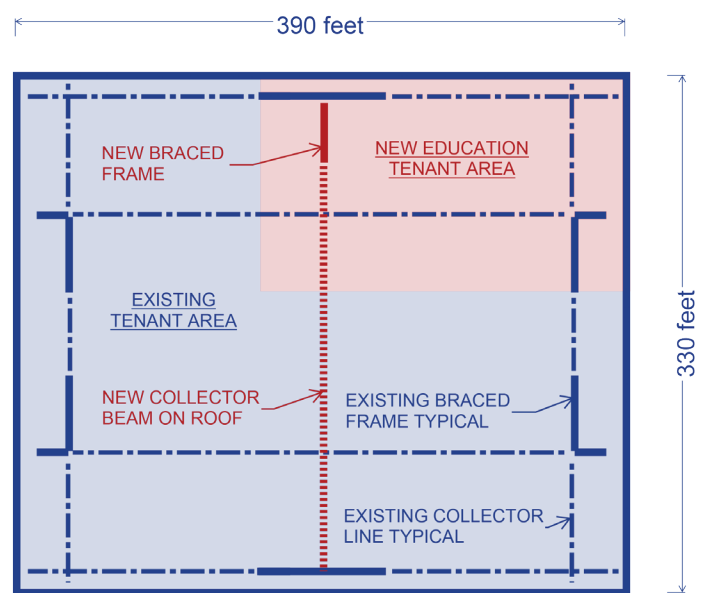
OVERALL PLAN VIEW

Figure 2. Plan view of existing building, including lateral system layout and new versus existing tenant spaces.

There are six existing braced frames in the building (Fig. 2); four in the east-west direction and two in the north-south direction. The brace members have a relatively high width-to-thickness ratio. To improve ductility of these members, grout was pumped inside. This reduces the “soda can” effect of wall crushing during a cyclic tension-compression seismic event. Only one brace type lacked adequate tension capacity; cross-sectional area was added by welding plate material to increase the cross-section.

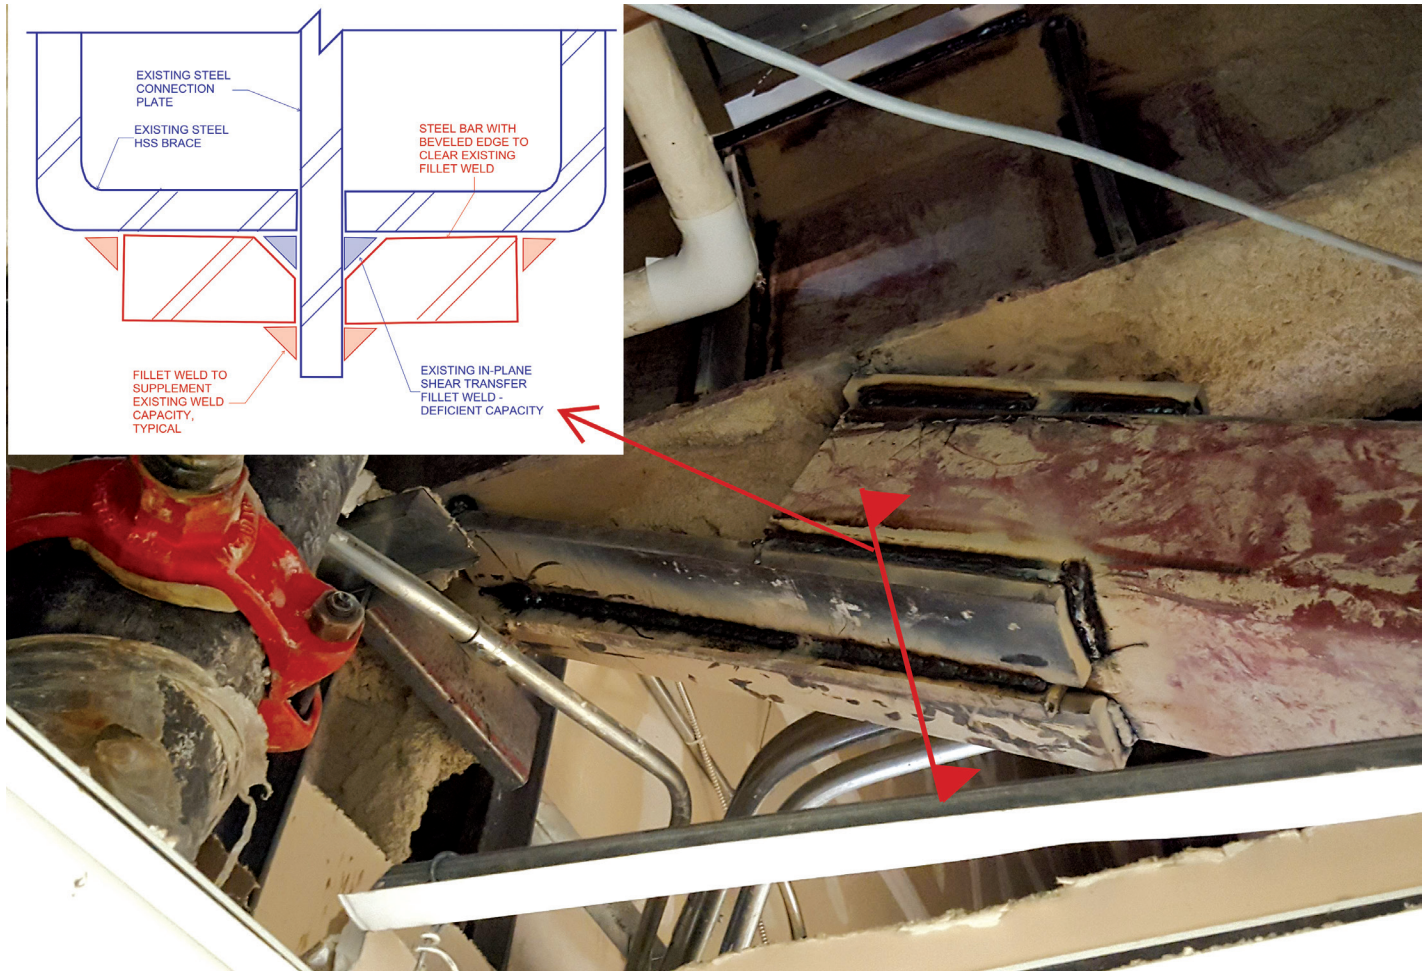
Almost all existing braced frame connection details required strengthening. Deficiencies included cross sectional steel area being inadequate, weld strength being inadequate, and plate buckling strength being inadequate. Beveled bars were used to add weld over the top of existing welds without introducing new weld directly to the existing (Fig. 3). This also kept the new weld sizes smaller, allowing fewer passes.

Figure 3. Top of existing braced frame brace retrofitted with additional weld and beveled drag bars.

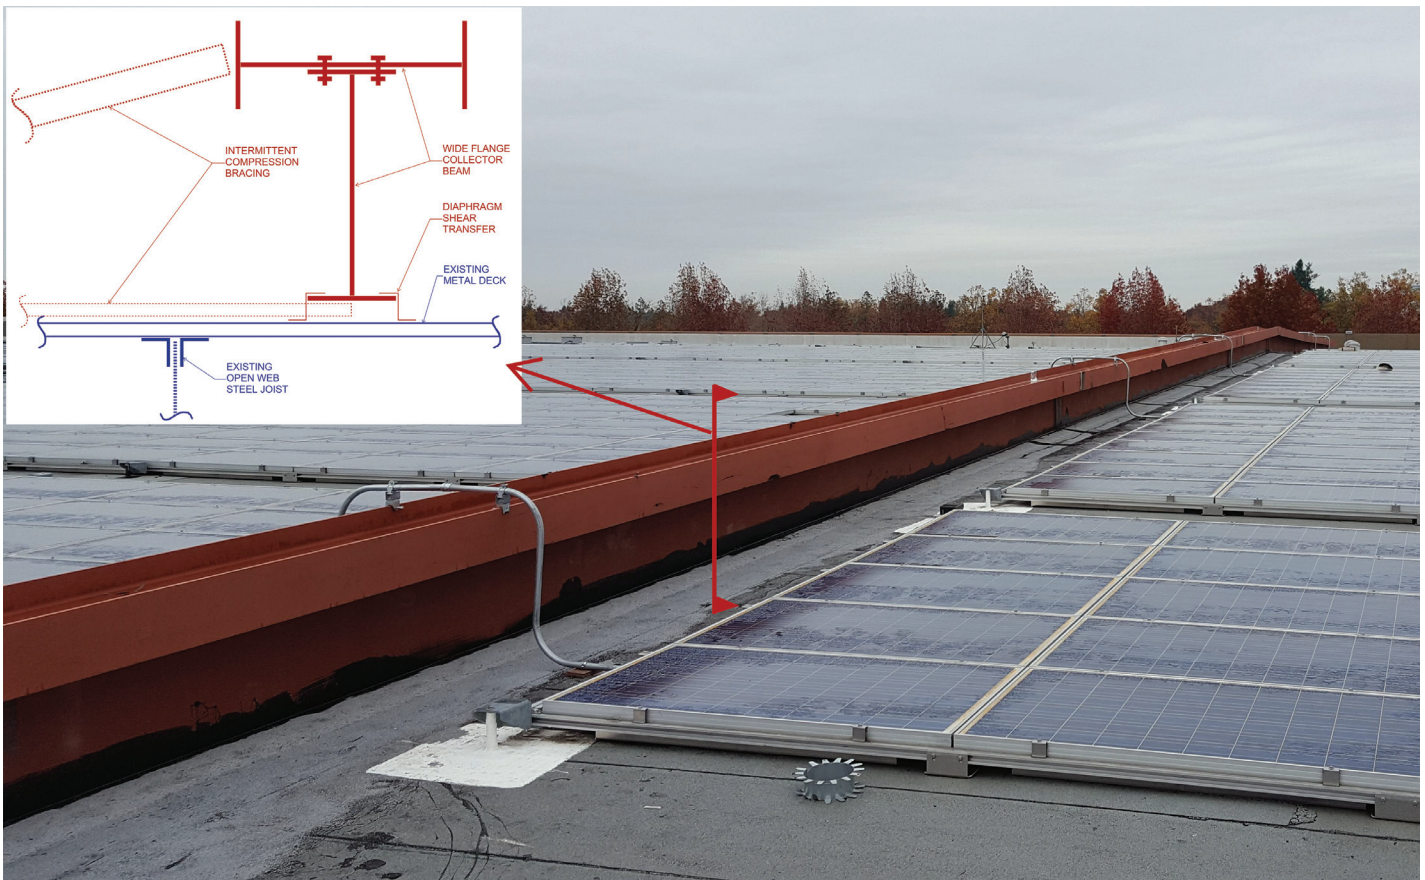
In the north-south direction, the only existing lateral force-resisting lines are located at the edges of the building; there are no interior lines of support. The entire load path from metal deck diaphragm through to base of braced frame was significantly overstressed. Therefore, a new line of resistance was added down the middle of the building in this direction. New braced frames fit the programming of the new school tenant space well. The area was already completely open, allowing for clear construction space to install the long interior steel elements, as well as new foundations, including micropiles. However, the new school tenant space reached only a little less than half the length of the building in this direction. The remaining length was occupied by other tenants, primarily the food processor, for which installing overhead beams in their space was a nonstarter. The existing steel roof framing along the new collector line was a typical open web joist, only designed for gravity loads. The design team opted to install new framing on top of the roof to collect load from the diaphragm over the other tenants' space and drag the load to the new braced frame (Fig. 4). A tee-shaped beam section was used for this new collector by installing one wide flange in a traditional, vertical orientation, but placing a second wide flange sideways on top of the first. This allowed for fewer top flange bracing connections down through the roofing. The two stacked beams were

Figure 4. The new collector element installed on the top of the roof.

placed atop the existing roof diaphragm to continue the collector line across the width of the building.

This solution was not without its own challenges. The building owner lost a number of photovoltaic panels where the new collector was placed. Existing surface-mounted utilities had to be lengthened to jog over top of the new several-feet-tall collector. New roofing penetrations were required to connect the new framing to the existing framing below. However, these tradeoffs were outweighed by the ability to allow the new tenant to occupy the space without disturbing the existing tenants.
