HISTORIC ALAMEDA HIGH SCHOOL RETROFIT

PART 2: PRESERVING HISTORIC VALUE, PROVIDING MODERN SEISMIC SAFETY

By Nik Blanchette, P.E., Steve Heyne, S.E., and Chris Warner, S.E.

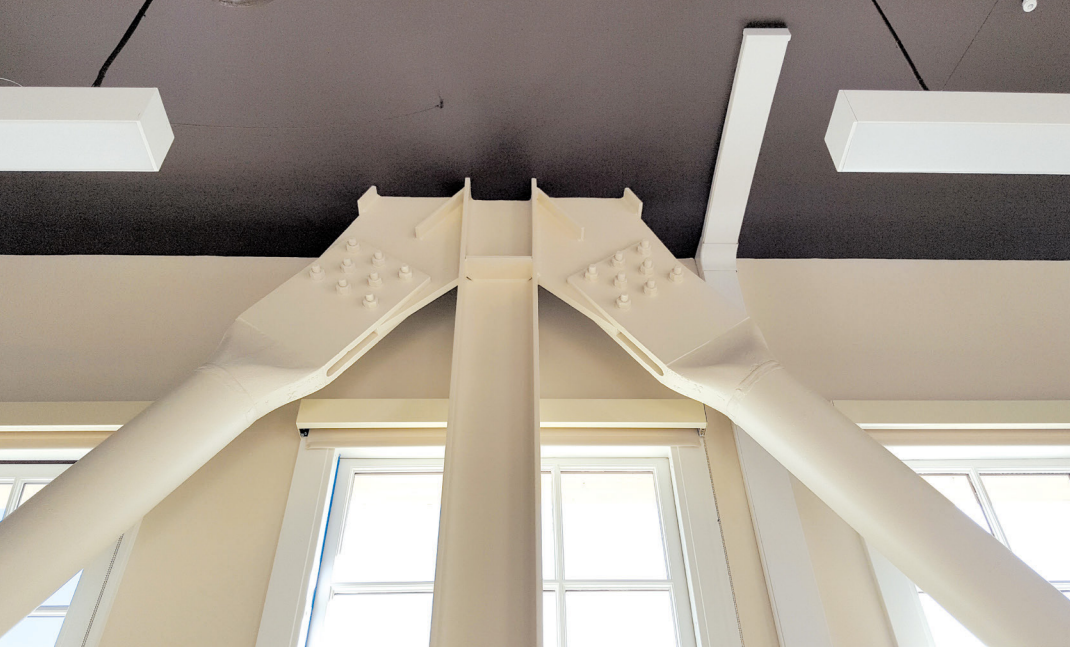
Cast Connex HSC brace connection.

A new steel SFRS was another option to evaluate. Steel offers an efficient, compact, and modular solution. Relatively lightweight elements can be fabricated offsite then installed through small openings in the building. Comparing braced frames and moment frames, braced frames were selected due to their greater stiffness, which was required to limit in-plane drift of the existing concrete walls. Drift was limited to prevent yielding of the existing reinforcing steel in the concrete walls supporting floor and roof gravity loads. Braced frames also integrate better with wood-framed floors since the beam bracing requirements for moment frames are difficult to resolve into wood framing. Architecturally, it was decided not to encase the frames in finishes, so Cast Connex High-Strength Connectors were utilized at brace to gusset plate connections instead of traditional welded or bolted connections. The connectors are more

visually appealing and allow for field bolted connections, which was more cost-effective to install.

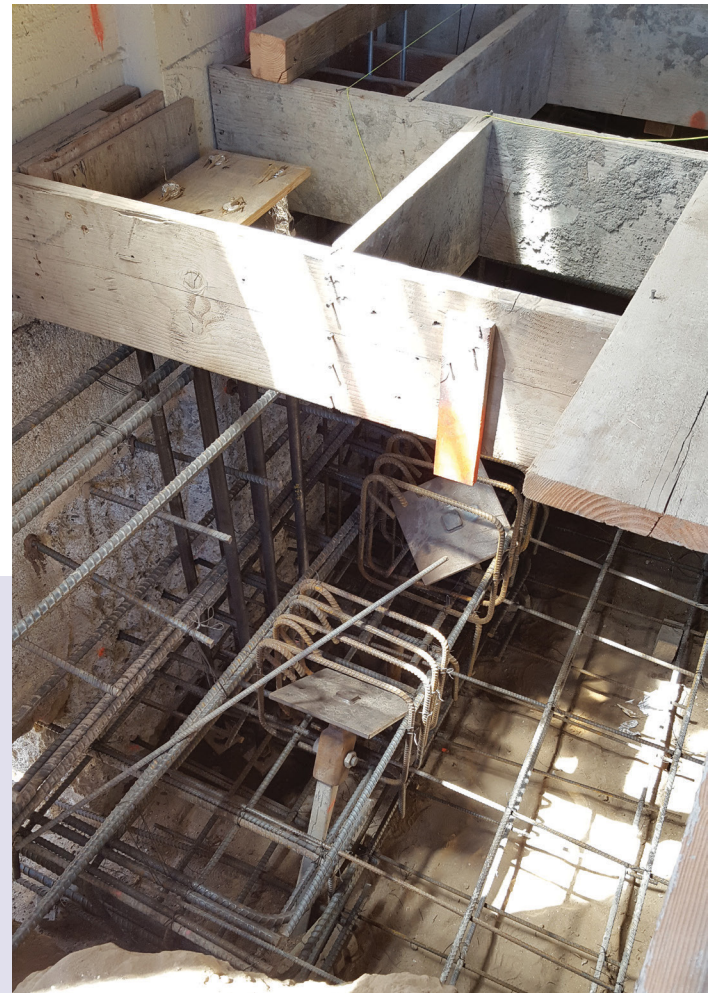
Top of battered helical piles at pile cap.

HELICAL PILES ARE
MODULAR ELEMENTS
COMPOSED OF RELATIVELY
SLENDER STEEL SHAFTS WITH
LARGER DIAMETER HELICAL
PLATES ON THE LEAD END.

Three-story-tall braced frames supporting concrete wall construction result in sizeable seismic overturning demands. High demands combined with the need to fit new foundations within the footprint of an existing building, with pad footings throughout, required deep foundations. Due to limited access and vertical clearances within the existing building, helical piles were chosen for the new foundations that were installed under the braced frames. Helical piles are modular elements composed of relatively slender steel shafts with larger diameter helical plates on the lead end; essentially, a large screw torqued into the soil. These piles come in short lengths and can be installed with a hydraulic head mounted on a Bobcat, perfect for working inside an existing building. After one shaft is driven flush with the ground or slab, another shaft is added using a bolted coupler. Helical piles are stiff along their axis but weak perpendicular to the shaft. Therefore, vertical piles were used to support vertical forces but, to resolve base shear at the braced frames, battered piles at an angle of thirty degrees to vertical were used.

The pile manufacturer was unsure if the piles could be driven through the grout injection columns without damage and/or refusal. Therefore, the piles were installed first. After grout injection was performed, the foundations were excavated, taking care not to damage the embedded pile shafts. This was an unusual sequence but turned out to be successful.

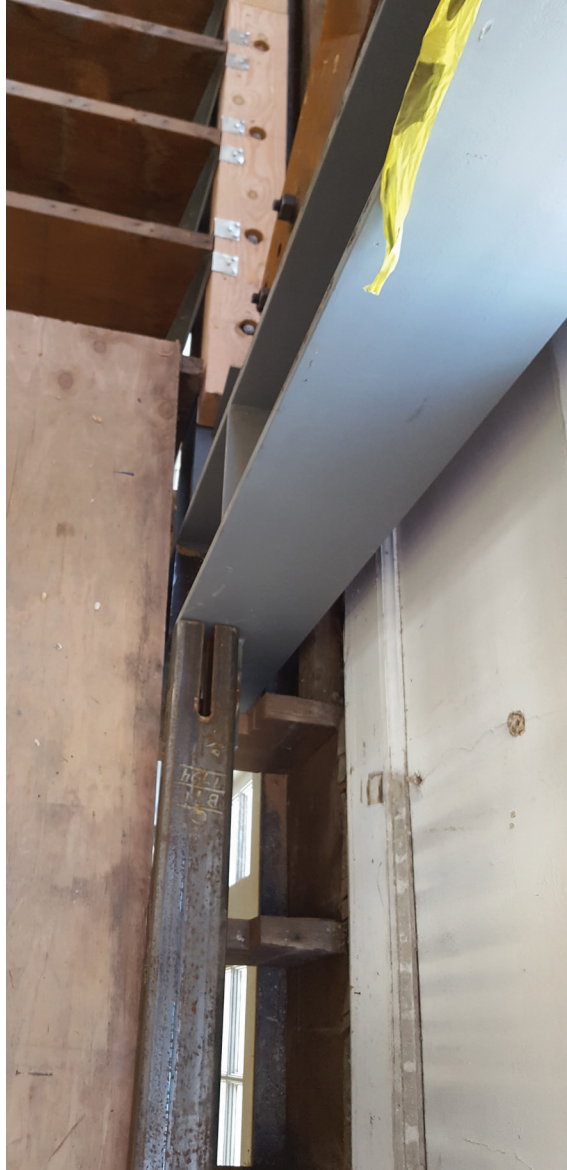
HSS collector recessed into the top of floor framing.

Existing concrete beam reinforcing was already fully utilized for gravity loads, so new collectors had to be introduced. It was challenging to integrate the new collectors with the existing gravity framing because they needed to occupy the same space to hide them from view and maintain historic visuals as much as possible. Braced HSS beams offered a small profile, which was hidden in the top of notched floor joist ends. Roof collectors were hidden in the attic. This resulted in only braced-frame elements being exposed in a limited number of rooms.

New steel collectors had to pass through perpendicular concrete beams in many locations. An elaborate set of condition-specific details was developed, using steel rods to limit the extent of concrete removal. Field welding was avoided in most cases, favoring a threaded rod and nut solution.
