Homestead High School Retrofit

The comprehensive rehabilitation of a Silicon Valley high school used a composite solution.

By Nik Blanchette, SE, Steve Heyne, SE, and Chris Warner, SE

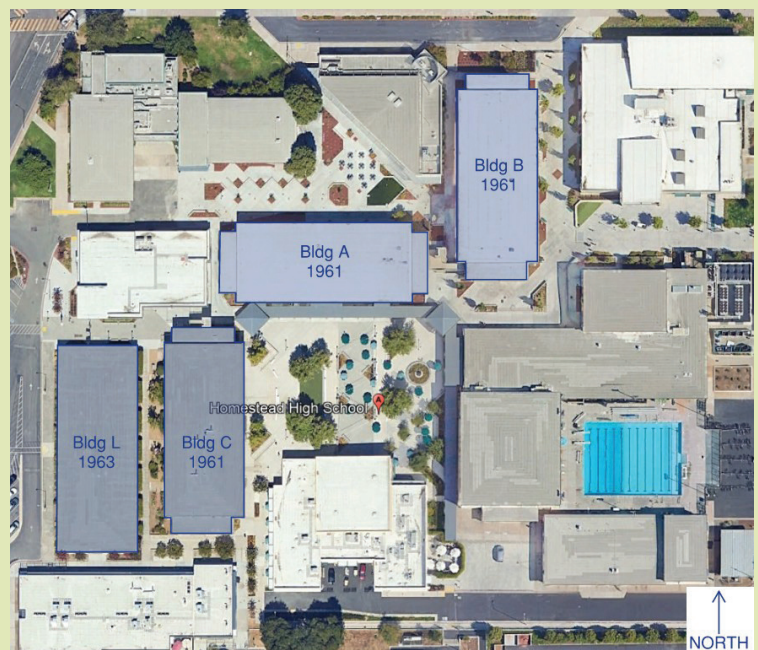
Fig. 1. As shown in this campus site plan, the high school rehabilitation scope included Buildings A, B, C, and L. Image credit: Google Earth

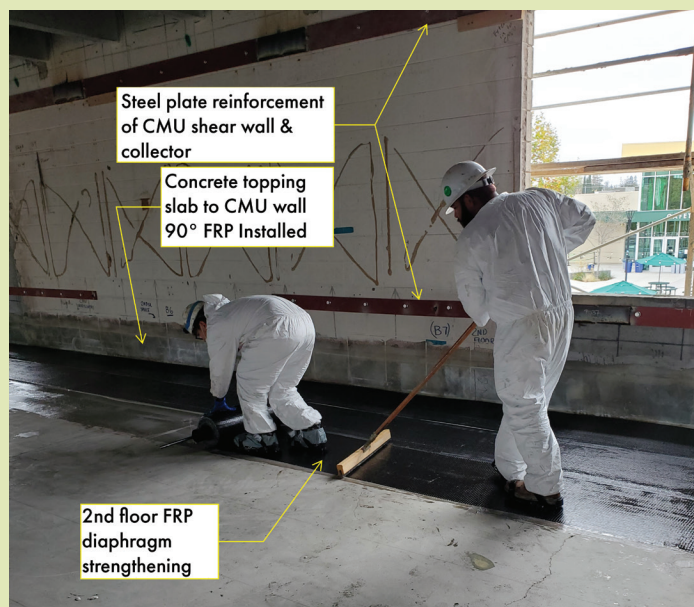
Fig. 5. Steel plates were used for CMU wall shear wall and collector strengthening. FRP diaphragm strengthening is installed by unrolling epoxy-saturated fabric.

FRP solved a great number of challenges in the seismic retrofit of these buildings; however, another solution was utilized for strengthening of collectors and in-plane shear transfer in some locations—steel (Fig. 5). Steel was a viable option for collectors specifically due to their isolated locations, which allowed for localized swaths of material; unlike the diaphragm that involved the entire area of the floor. FRP was considered for collector strengthening but the enormous seismic mass of the buildings produced such large collector forces that steel was more economical. Steel plates, field welded together to allow

the Contractor to select their splice locations, were anchored to the existing collectors with screw anchor bolts at 24 inches-on-center, to provide strengthening in both compression and tension. Similarly at transverse walls, in-plane shear strengthening was achieved using bent steel plates bolted to the diaphragm and connected to the wall with screw anchor bolts. In addition to the dramatic structural upgrades, nonstructural improvements were a crucial piece of this project.
