Napa County HISTORIC Courthouse

By Luke Wilson, S.E.,
Brett Shields, P.E.,
and Kevin Zucco, S.E.

Napa County HISTORIC Courthouse PART 2

Napa County HISTORIC Courthouse PART 3

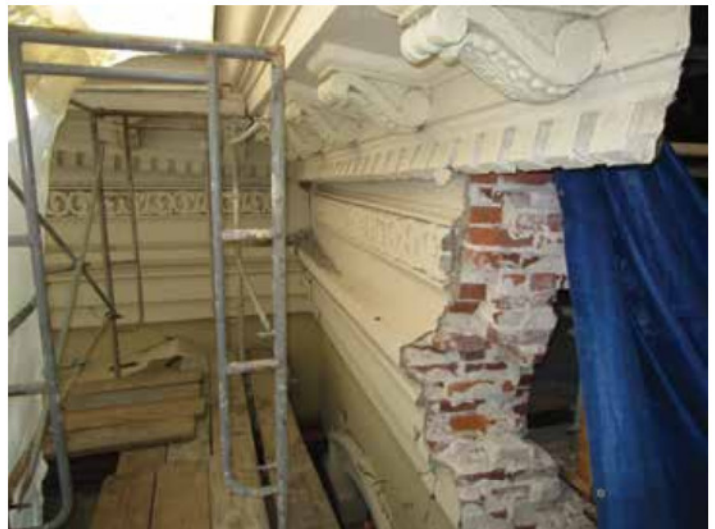
Figure 2. Historic exterior wall brick construction and dental cornice.

Early in the repair design, the design team considered using traditional Fiber Reinforced Polymer (FRP) overlay on brick walls demonstrating extensive cracking. Due to surface preparation requirements and material incompatibilities of FRP (epoxy resin vs clay and mortar), the team turned to a new overlay product uniquely suited for brick masonry construction called Fabric Reinforced Cementitious Matrix (FRCM) used extensively in Europe. FRCM was used to repair brick

masonry walls with significant cracking but minimal permanent deformations, and to provide continuity through floors, walls, and around corners. As a new product being brought to the United States by manufacturers, including Simpson Strong-Tie, FRCM presented several challenges and opportunities from design through construction. These will be discussed in a future Part 3 article in *STRUCTURE*.

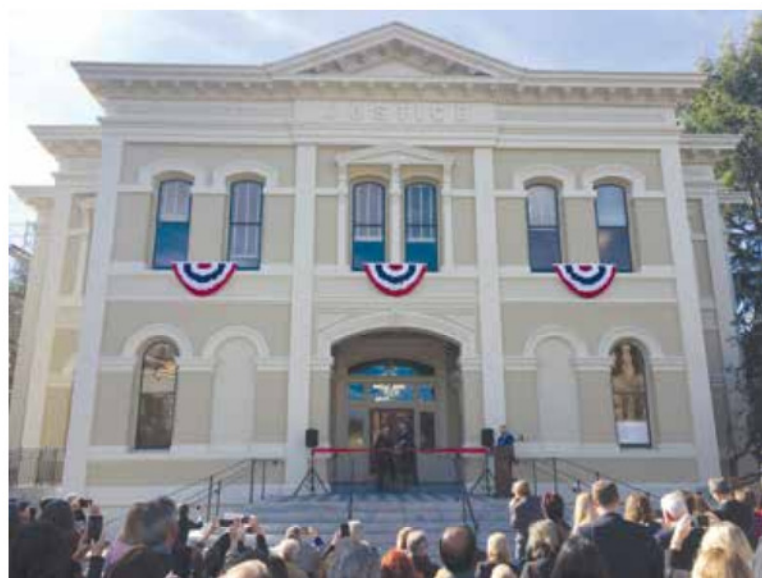
Figure 8. Grand opening on January 22, 2019.

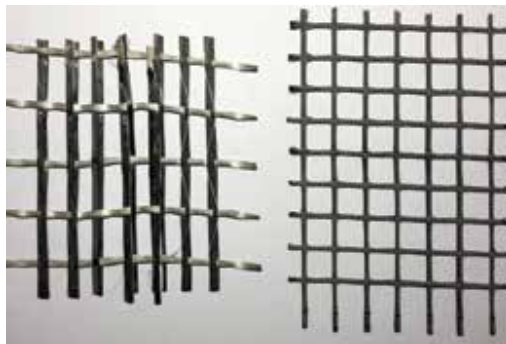
Figure 2. FRCM uni-directional (left), bi-directional (right).

During concept design, an overlay product used extensively in Europe, Fabric-Reinforced Cementitious Matrix (FRCM), was being introduced to the California market by manufacturers including Simpson Strong-Tie. FRCM consists of either uni-directional or bi-directional carbon fiber fabric (Figure 2) embedded between lifts of cementitious matrix installed in ¼- to ½-inch lifts. The lifts can either be installed by hand similar to plaster, or as a spray installation similar to shotcrete. The fabric, which comes in rolls up to 77 inches wide, is pressed into the base lift before having a cover lift of matrix

installed. The total thickness for one layer of FRCM is approximately 1 inch plus ½ inch for each additional layer of FRCM. As a porous cementitious material, FRCM is more homogeneous with existing brick stiffness and mechanical properties compared to epoxy-based overlays and allows the historic brick to breathe. The FRCM surface preparation only requires a surface clear of loose debris, cleaned, and saturated surface dry for cementitious matrix adhesion and curing. The FRCM can double as the base coat for plaster installation, removing an extra preparation step required for FRP.
