REPAIR AND RETROFIT IN THE AFTERMATH OF THE 2014 NAPA EARTHQUAKE

By Chris Jonas, S.E., and Steve Heyne, S.E.

HISTORIC GOODMAN LIBRARY

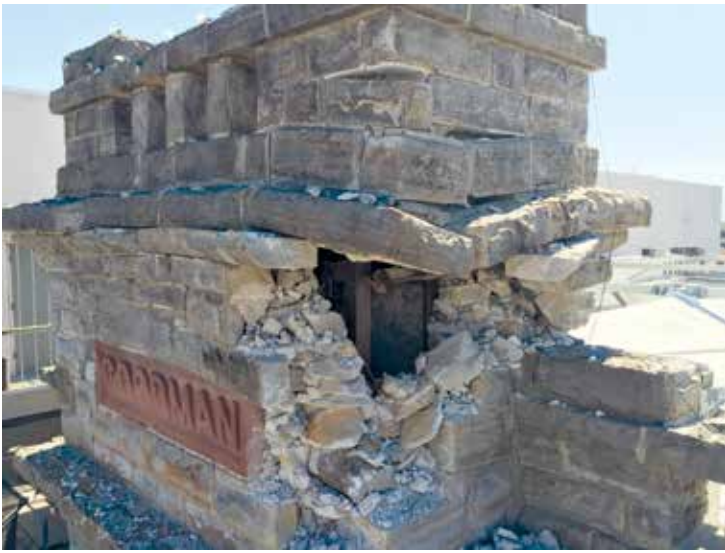
During the early morning hours of August 24, 2014, many of Downtown Napa's historic buildings sustained moderate to heavy damage due to the powerful 6.0 magnitude earthquake that struck just over 5 miles away to the southwest. Among those was the iconic Goodman Library located in the heart of the city. All the building's stone walls sustained damage in the form of cracks, but it was the partial collapse of its prominent tower that was remarkable (*Figure 1*). Shocked passers-by and news media assembled to view the stone rubble strewn about the sidewalk and to contemplate a "what if" scenario had the earthquake occurred during the downtown music festival just a half day prior. Barricades were established around the front of the building to protect bystanders from the dangers of large stones that could still come down. The partially-collapsed tower seemed to defy the laws of gravity, and even the smallest aftershock could quickly complete the demolition process, but, to everyone's disbelief, most of the historic tower remained in place, damaged but not destroyed.
