The Historic Trefethen Winery

Repair and Retrofit in the Aftermath of the Napa Earthquake

By Marianne Wilson, S.E., Kevin Zucco, S.E., and Brett Shields, P.E.

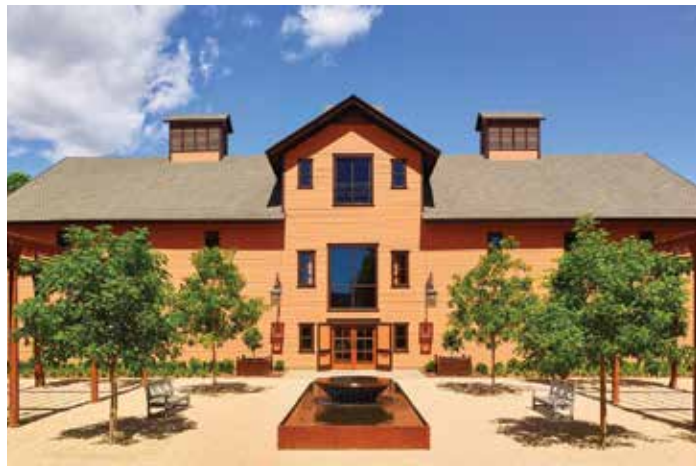
Figure 8. Renovations completed in 2017. Courtesy of Adrian Gregorutti and Trefethen Family Vineyards.

The structural repair and retrofit were completed in the Fall of 2016. The revitalization of the winery building continued with interior architectural improvements to provide a new guest experience and improved winemaking facilities. The lower level winemaking areas are now showcased through glazed walls on either side of the center bay, with more barrel storage and the tasting room at the second level. These features allow guests to appreciate the two-story vaulted space with historical redwood siding and views of the estate vineyard. Renovations were completed for a grand reopening of the tasting room in May 2017 (Figure 8).▪
