# THE FLOATING GYM: ENGINEERING A NEW BUILDING ABOVE AN EXISTING STRUCTURE THAT CANNOT BE ALTERED

Matt Frantz, SE, Principal; Nick J. Reid, SE, Principal  
ZFA Structural Engineers  
San Francisco, CA

## Abstract

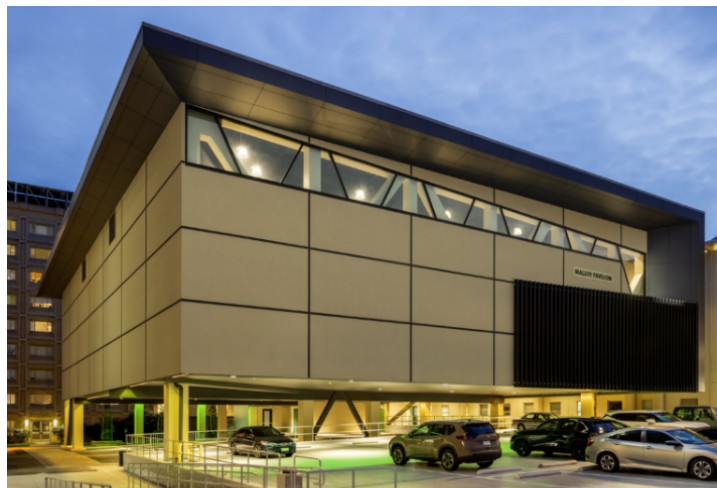
Figure 1: Malloy Pavilion, the "Floating Gym," Looking South

Completed in 2023, the new Malloy Pavilion at the University of San Francisco (USF), shown in Figure 1, is a state-of-the-art, 16,800-square-foot NCAA practice gymnasium with basketball and volleyball courts, as well as office space. Due to limited space on campus, the site chosen for the new gymnasium posed a major challenge—it is also home to a below-grade concrete parking garage built in 1965 that is attached to a mid-rise Hayes-Healy Residence Hall. The site is also bordered closely on the other side by the War Memorial Gym at Sbrato Center.

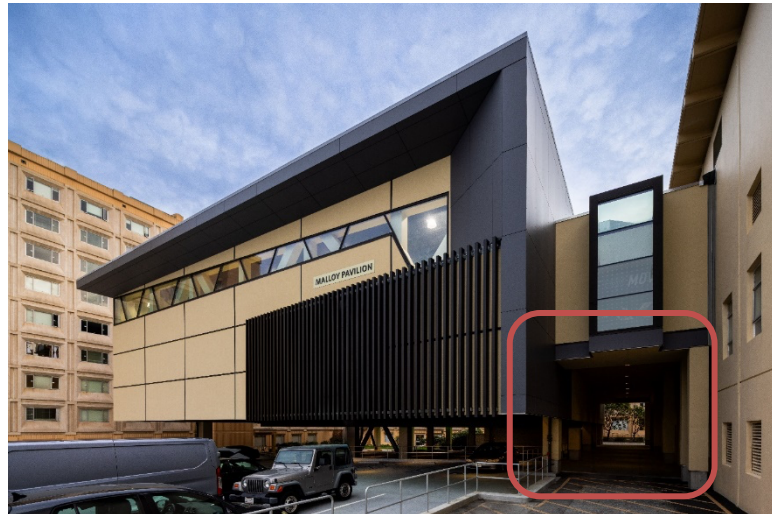
*Figure 2: North Building Elevation, Fire Lane Highlighted*

USF also needed to maintain the existing California Fire Code-required fire lane located between the older gym and the below-grade parking garage. By elevating the finished floor level of the new gym floor approximately 15 feet above the grade of the existing surface parking, code-required overhead clearances could be satisfied for continued use of the fire lane, as shown in Figure 2. Structure depths in this area were closely coordinated to ensure the minimum clearances were met.

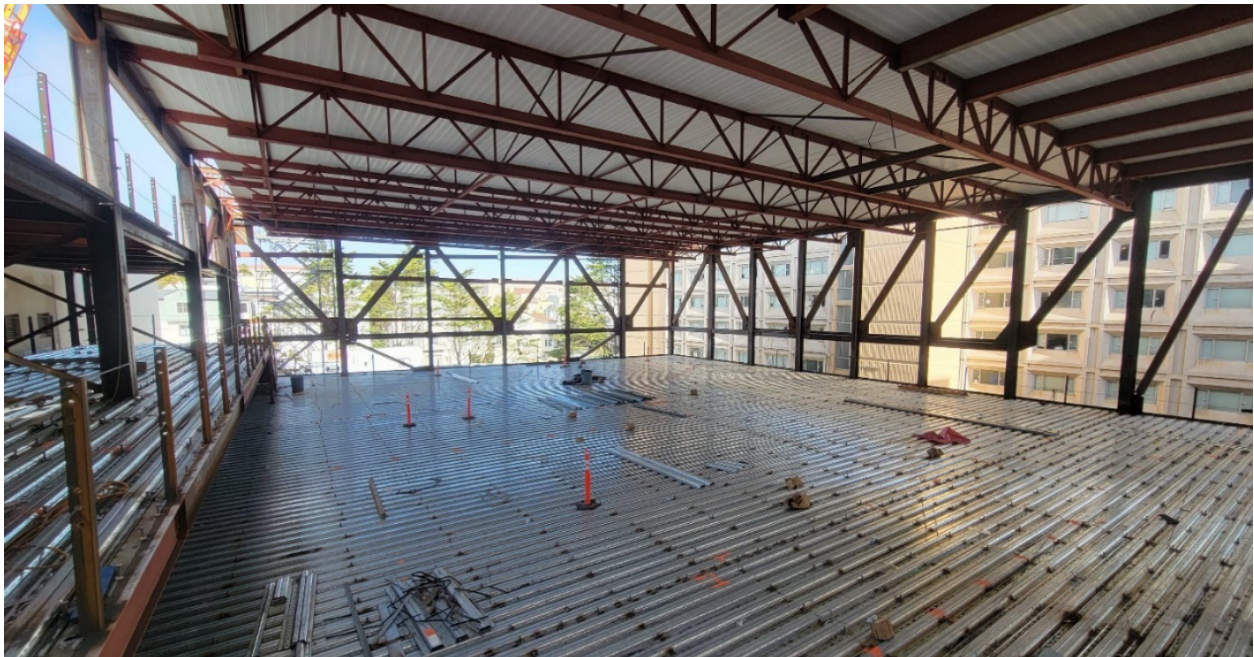
Figure 5: Custom Open Web Roof Joists Over the Main Gym Floor; Truss A at the Far Wall, Truss C to the Right

Plate girders were utilized in multiple locations to provide the required strength and stiffness, while ensuring the overhead clear height was maintained above the parking areas below. At the roof, custom open web joists span 100 feet over the court, while allowing ductwork to run through the webs and maintain the required clear height over the court below, as shown in Figure 5.

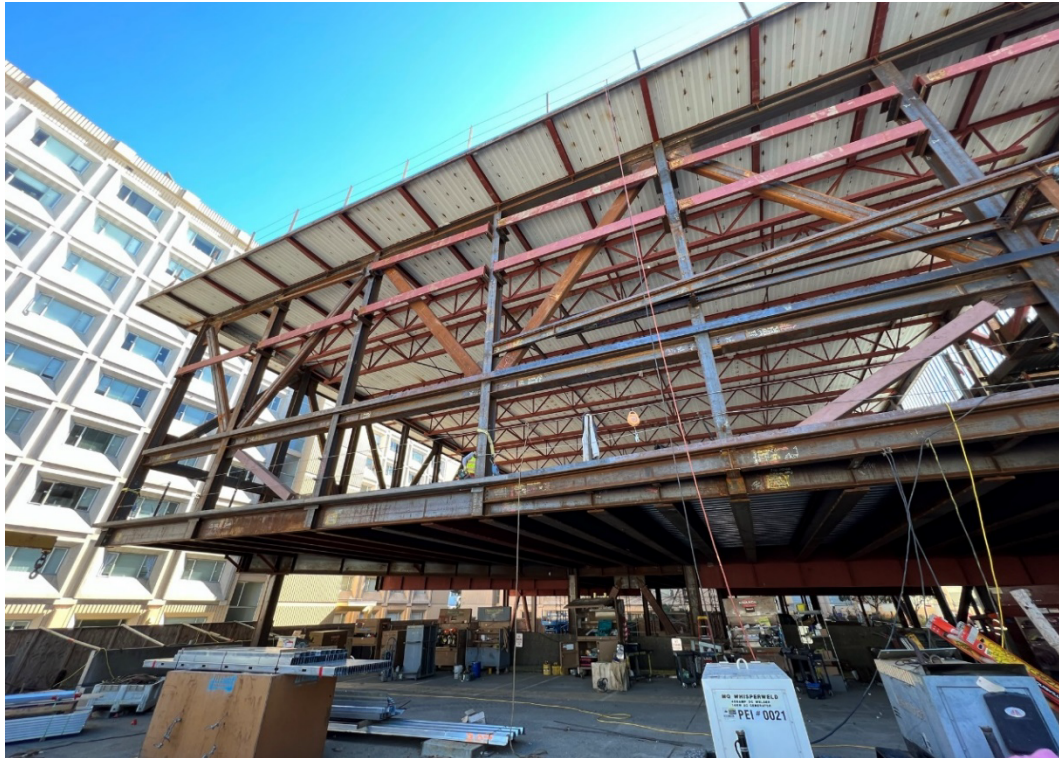
Figure 7: North Elevation Showing Truss A During Construction

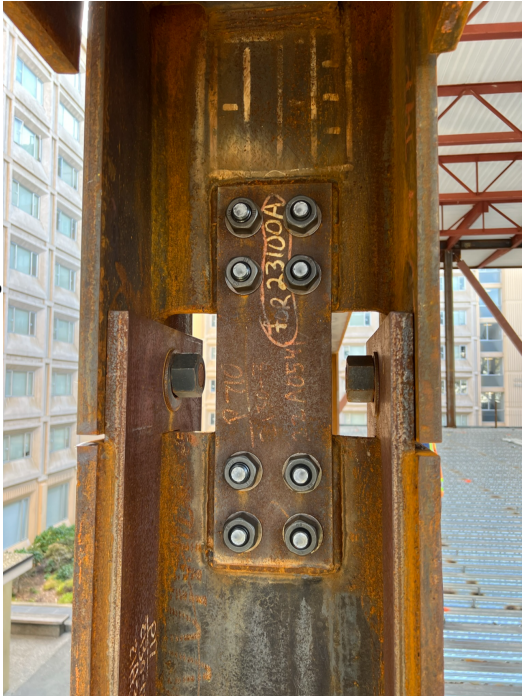
15 TRUSS CONNECTION DETAIL  
3/4" = 1'-0"

Figure 10: Hinge Connection at Truss C

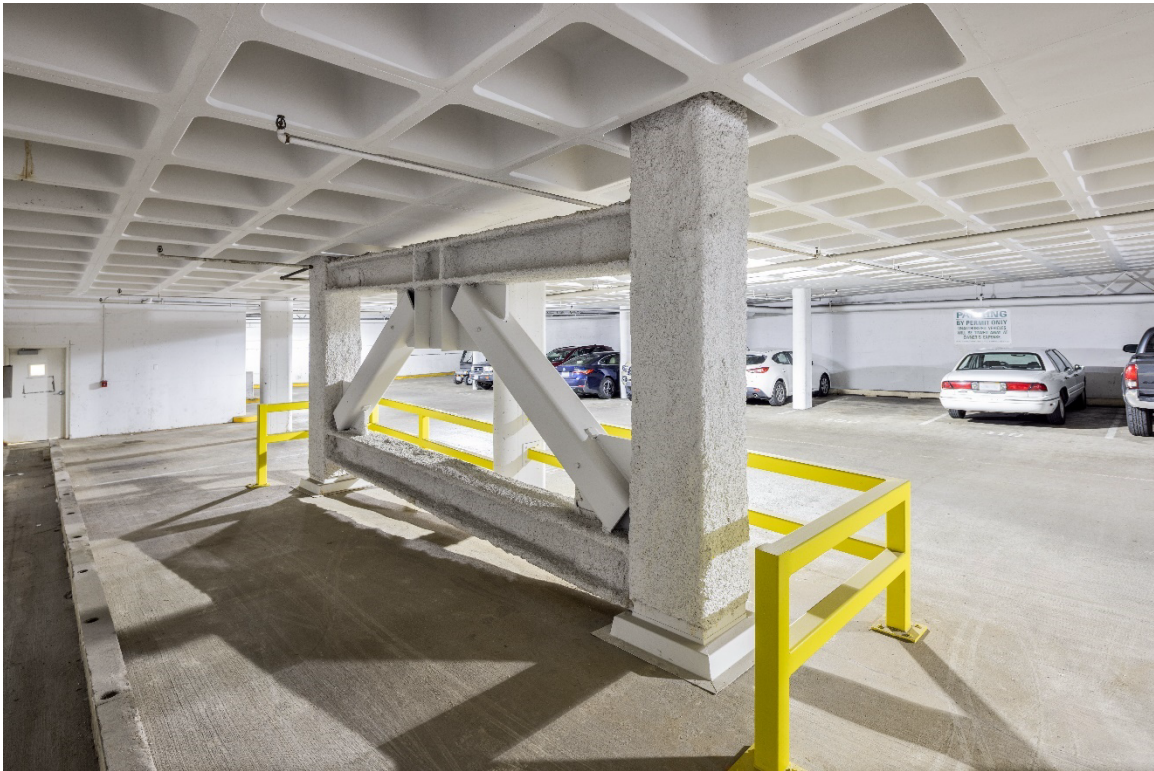
Figure 15: Braced Frame Installed at the Lowest Level of the Parking Garage

The elastic frame consists of a braced frame from the foundation to the underside of the lower garage level, shown in Figure 15, a small gap where columns penetrate the garage floor and flexural deformations define the response, then another rigid frame between the lower and upper garage levels. Above the garage, another horizontal beam forms the base for the gussets of the inelastic BRB frame.

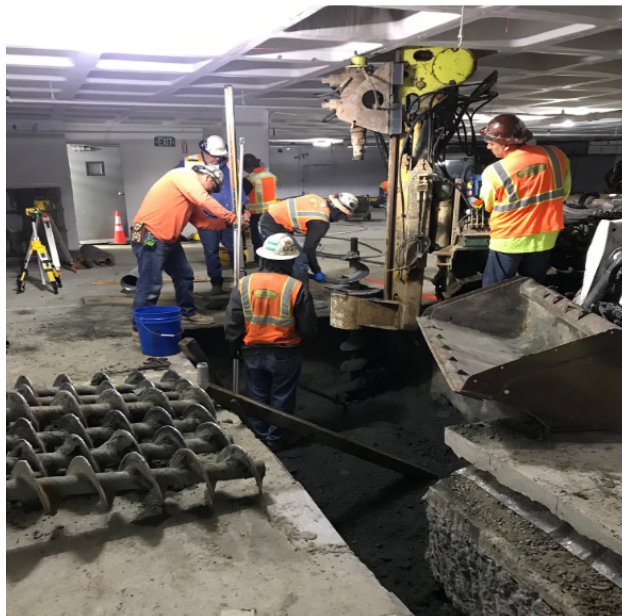
Figure 18: Low-Overhead Drill Rig to Install Micropile Foundations at the Bottom Level of the Existing Parking Garage

Due to the configuration of the superstructure, a majority of the micropiles are located outside the perimeter of the existing below-grade parking garage and were installed with a conventional drill rig. To support the three columns that penetrate through the parking garage, three pile caps, each with multiple piles, are located within the lowest level of the parking structure. These three pile caps were required to be installed with a low-overhead drill rig that could access the lowest garage level, as shown in Figure 18.

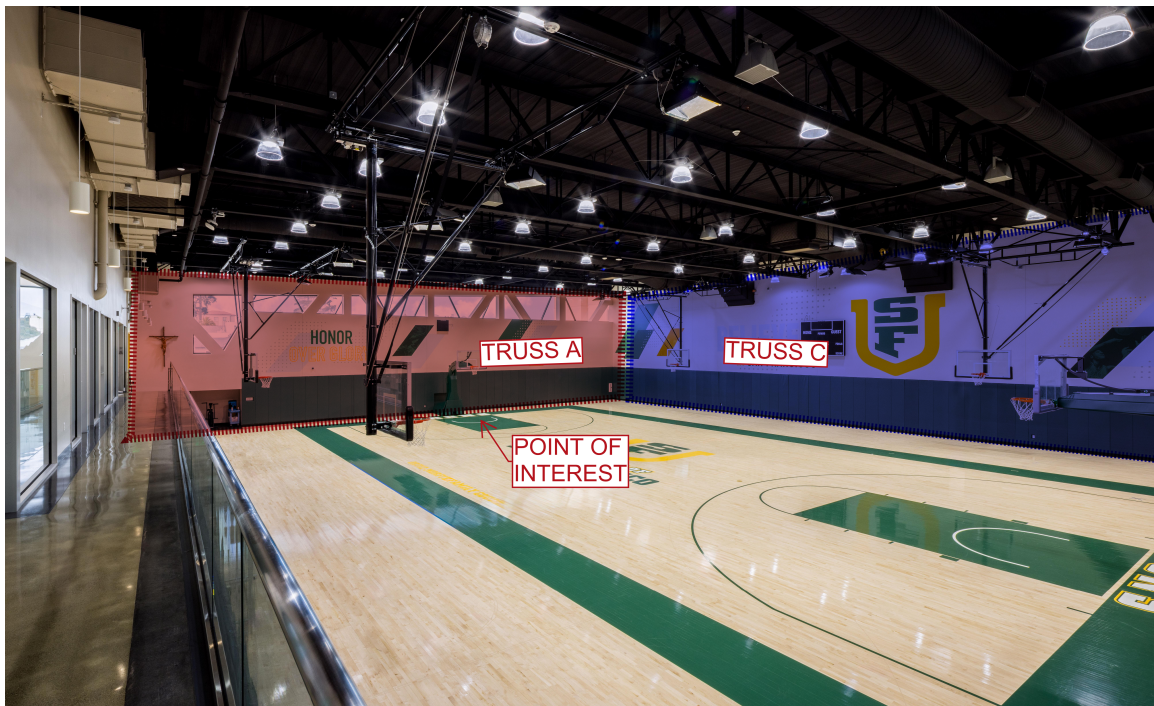
*Figure 22: Interior of Finished Gym Looking North, Showing "Point of Interest" for 3D Vibration Analysis*

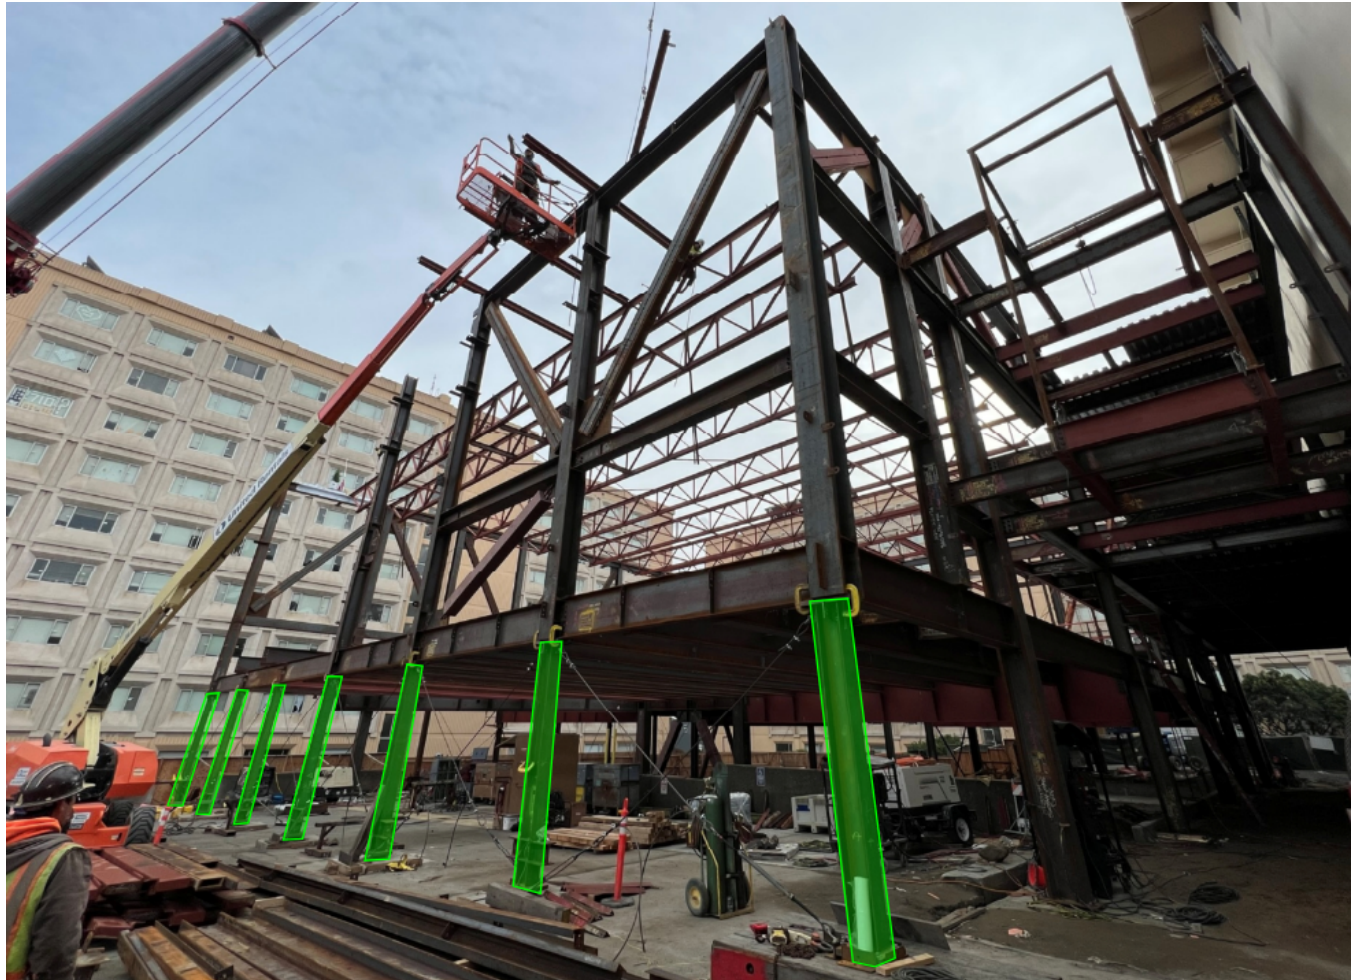
*Figure 24: Temporary Shoring Posts (Green) To Support Long-Span Truss During Erection*

Due to the limited space at the construction site, along with the required construction activities, the top level of the existing parking garage was required to be used for both the storage of construction materials and for temporary support of the new structure. These temporary loading conditions required shoring to be installed within all levels of the underground parking structure. At the storage areas, shoring posts were installed in a grid throughout each level. For the temporary support of the new structure, shoring posts were installed below exterior wall lines to enable the wall trusses to be erected and field welded piece by piece, as shown in Figure 24. These shoring posts were also required to be installed at each level of the garage to transfer loads down to the supportive soil below. Once all the components of the wall trusses were installed, fully welded, and inspected, the shoring posts were removed to allow the superstructure to support itself as designed.
