# Napa County HISTORIC Courthouse PART 3

By Brett Shields, P.E., Luke Wilson, S.E., and Kevin Zucco, S.E.

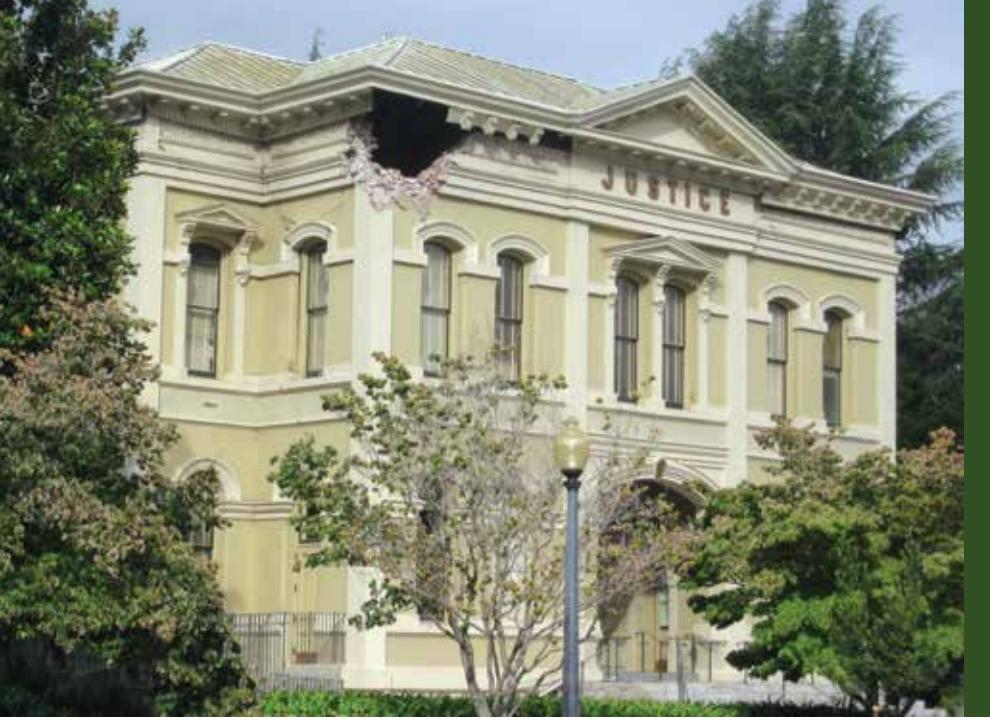
Figure 1. Entry showing damage taken the morning of the earthquake.

On August 24, 2014, the South Napa Earthquake left the Napa County Historic Courthouse heavily damaged with partially collapsed walls, ceilings, and extensive wall cracking (*Figure 1*). The City of Napa red-tagged the courthouse as unoccupiable, which began the extensive damage documentation and repair effort. The overarch-

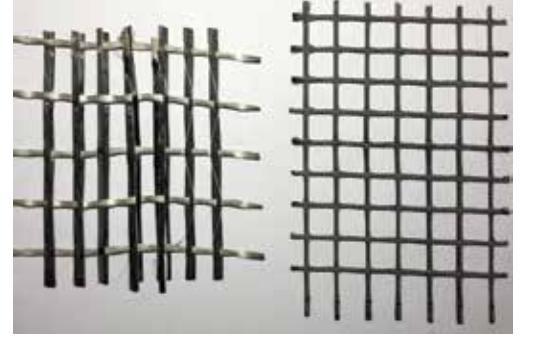
Figure 2. FRCM uni-directional (left), bi-directional (right).

the California market by manufacturers including Simpson Strong-Tie. FRCM consists of either uni-directional or bidirectional carbon fiber fabric (*Figure 2*) embedded between lifts of cementitious matrix installed in ¼- to ½-inch lifts. The lifts can either be installed by hand similar to plaster, or as a spray installation similar to shotcrete. The fabric, which comes in rolls up to 77 inches wide, is pressed into the base lift before having a cover lift of matrix ckness for one layer of FRCM is approximately

installed. The total thickness for one layer of FRCM is approximately 1 inch plus ½ inch for each additional layer of FRCM. As a porous cementitious material, FRCM is more homogeneous with existing brick stiffness and mechanical properties compared to epoxy-based overlays and allows the historic brick to breathe. The FRCM surface preparation only requires a surface clear of loose debris, cleaned, and saturated surface dry for cementitious matrix adhesion and curing. The FRCM can double as the base coat for plaster installation, removing an extra preparation step required for FRP.

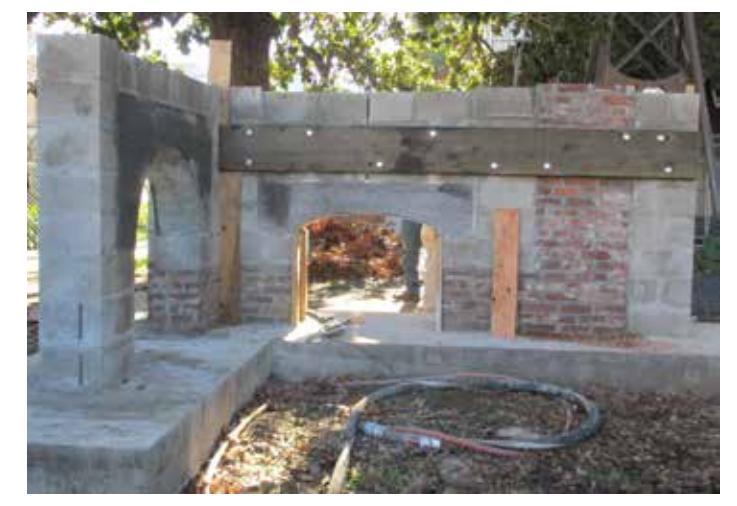
The mockup consisted of approximately 19 linear feet of a six-foottall wall in an 'L' configuration (plan view). It included the two typical window head configurations, an exterior corner pilaster, multiple CMU to brick interfaces, control joints, and a wood ledger to install FRCM splay anchors through. Once the structure was completed, FRCM was installed over each of the four sides on two separate days.

Figure 3. Mockup prior to installation of FRCM.

The mockup was completed early in the construction schedule and observed by the Design Team, Owner's Representative, General Contractor, multiple representatives from Simpson Strong-Tie, and Project Inspector of Record (IOR). The group debriefed after each installation and circulated lessons learned. Through this process, multiple installation techniques were tested to ensure 1/2-inch lift heights. Ultimately, the most effective process was determined to be having preset feeler gauges, spot-checking the material as it was installed and using wires to set the final depth (Figures 3 and 4) similar to traditional shotcrete installation techniques.

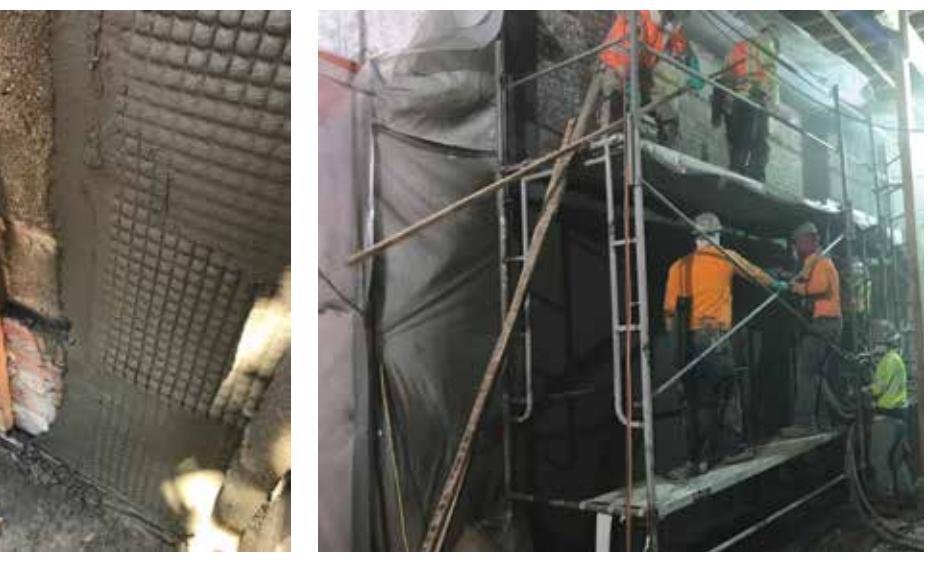
Figure 4. FRCM fabric being installed into matrix.

FRCM was installed with a pump, hose, and nozzle, similar to shotcrete. Typical shotcrete lifts are three to four inches minimum, meaning there was a learning curve to install the ½-inch lifts required for FRCM. The size of the walls complicated this. The typical wall height was 16 feet on the first floor and 18 to 20 feet on the second floor, requiring multiple levels of scaffolding to access (*Figure 5*). Matrix had to be installed around scaffolding, leading to shadowing and/or thin spots at the scaffolding planks and legs and thick spots at

the corners, floors, and ceilings. These variations had to be trimmed to meet flatness requirements for future wall finishes. If the matrix was too thin, the fabric could be unintentionally moved or damaged while worked into the first lift of matrix.

Additionally, scaffolding presented an obstacle to the installation of the large rolls of fabric. The fabric could not be sharply bent without damaging the fiber bundles or disconnecting the unidirectional grid from tie strands. Therefore, the FRCM had to be installed from a rolled bundle challenging to work around scaffolding. While the mockup was an excellent proof of concept and uncovered many installation hurdles, it had size limitations that did not uncover challenges of large-scale construction means and methods.

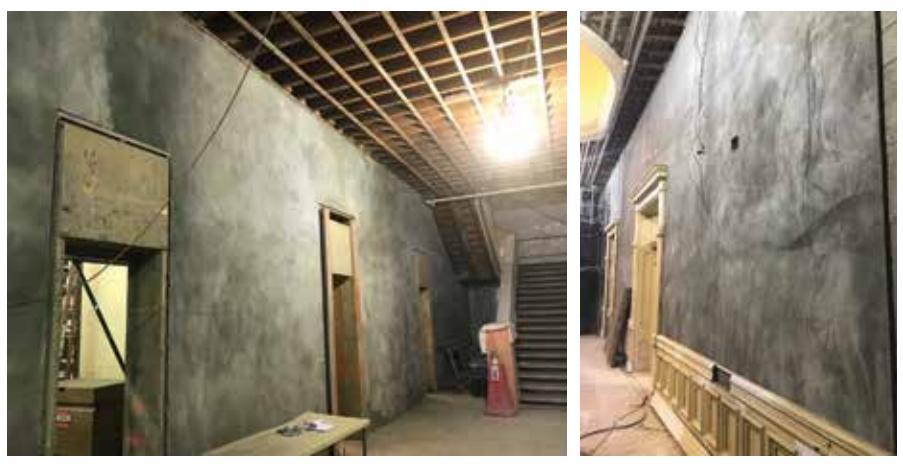
Figure 6. Finished FRCM installation on first floor (left), second floor (right).

FRCMs were used to provide in-plane and out-of-plane repair/ strengthening throughout the building, maximizing the amount of historic brick wall that was preserved. Its relatively thin application, substrate tolerance, material compatibility with the existing brick, and its allowance for the walls to naturally breathe were critical to providing a structural solution while minimizing the effect on the historic character of the building (*Figure 6*). FRP would have required significantly more surface preparation in comparison to FRCM, and discrete shotcrete walls would have affected room sizes and required strengthening of collectors and foundations. While FRCM had multiple benefits, using a new product to California presented several challenges during design and construction. These ranged from working with Simpson Strong-Tie as they developed design guidelines and material information, preparation of 140-year-old brick walls, and translating installation techniques from the mockup to working within the building. A dynamic and collaborative team approach was required by all involved to overcome these challenges.
